Applied Inspection Ltd

DEFECT DETECTION WITHIN CORRODED AXLE BODY SURFACES

Technical Committee 24 Seminar - Railway Axle Fatigue and Inspection at TWI 25 October 2012

Presented by Roy Archer (Technical Manager Rail - Level 3)

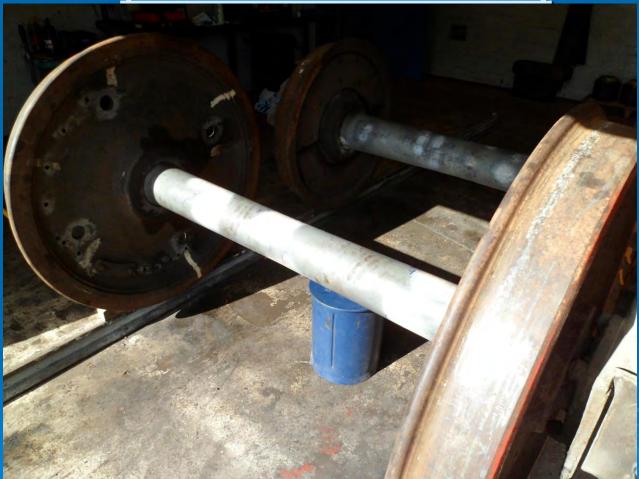
- Within the trials that have been carried out for WOLAXIM on two wheelsets with many corroded body areas available, one passenger and one freight type. Eddy Current Inspection, MPI Inspection using both a wrap round coil and yoke and different ink mediums were applied to corrosion patches on the axle body. Also a microscope was used to identify defects in the defective areas. These wheelsets were Eddy Current failures and have not been through any overhaul MPI process.

DEFECT DETECTION WITHIN CORRODED AXLE BODY SURFACES (TRIAL WHEELSETS)

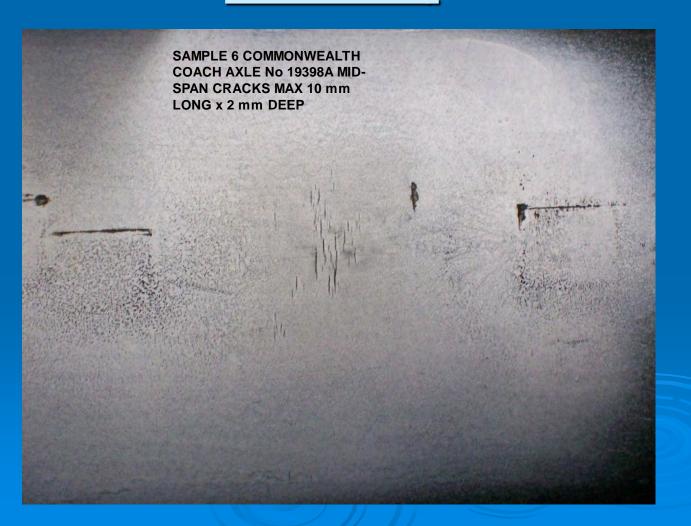
- It is my intention to put the two Applied Inspection wheelsets used in the WOLAXIM trials through a production process MPI split coil plant, but I anticipate that few defects will be identified and probably only the major cracked area with a defect 10 mm long x 2 mm deep in the coach axle, as per the following photograph will be detected at best.

DEFECT DETECTION WITHIN CORRODED AXLE BODY SURFACES (COACH WHEELSET TRIAL MAJOR DEFECTS)

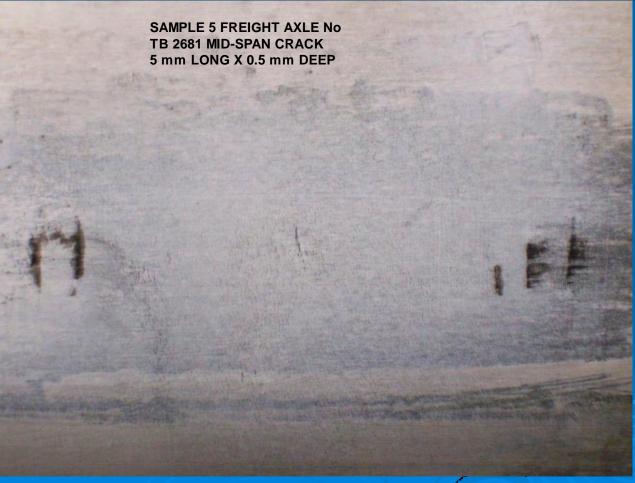
DEFECT DETECTION WITHIN CORRODED AXLE BODY SURFACES TRIAL FREIGHT WHEELSET DEFECT

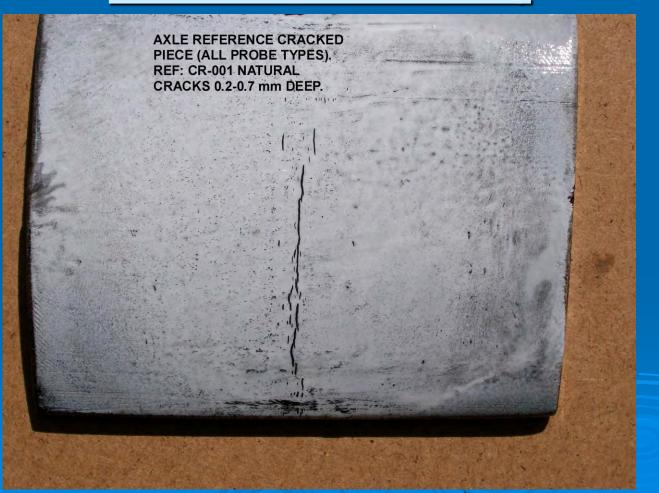
- The current amperages used at wheelset overhaul seem adequate regarding fretting type cracks in non blasted seat areas and a cracked test piece with 5 mm long fretting cracks x 0.5 mm deep works well to the current validation for this type of defect. However regarding a corroded cracked axle sample piece a crack 9 mm long x 1 mm deep could not be detected with this technique even at maximum coil amperage of 3676 amps rms positioned about 100 mm from the coils, but could be identified using a yoke. It must be stressed that each plant and the amperages required must be validated individually.

DEFECT DETECTION WITHIN CORRODED AXLE BODY SURFACES (EDDY CURRENT & MPI TEST PIECE FRETTING CRACKS)

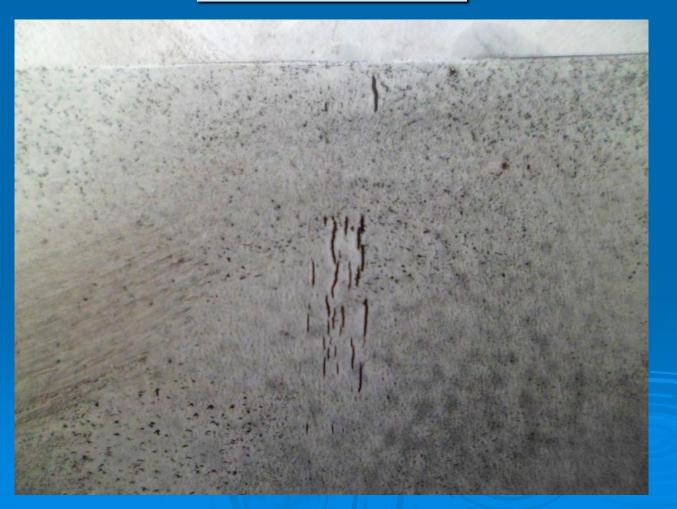
DEFECT DETECTION WITHIN CORRODED AXLE BODY SURFACES SECTION SAMPLE OF DEFECTS 0.2 MM DEEP

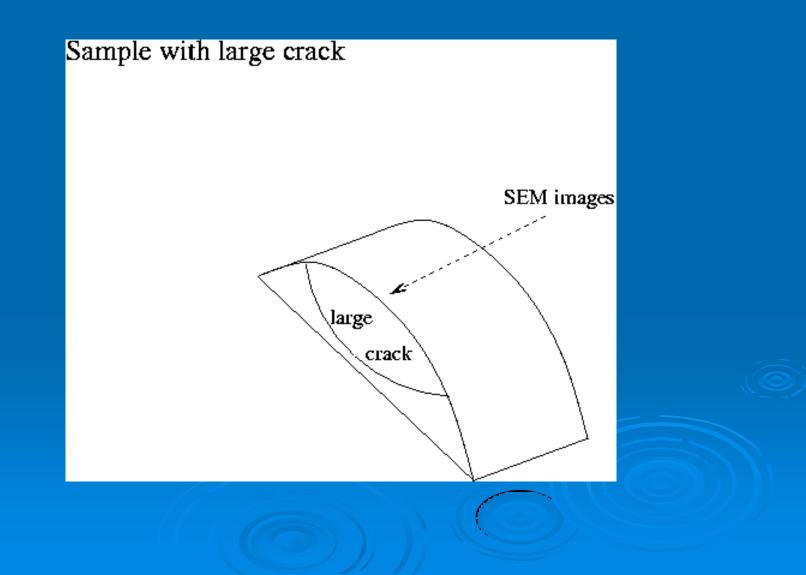
Large fracture face (mid-span crack)

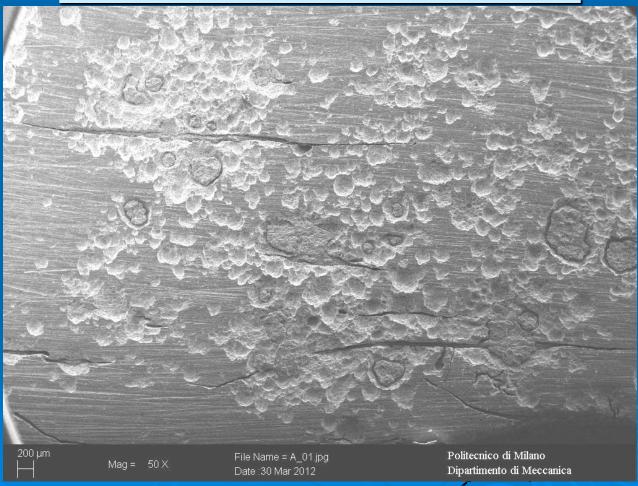
DEFECT DETECTION WITHIN CORRODED AXLE BODY SURFACES CRACKS MAGNIFIED 50X

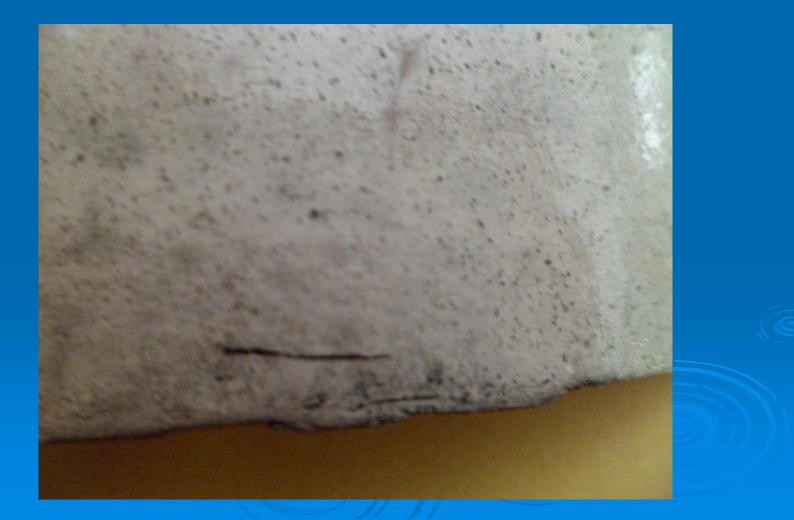
- The most effective method regarding MPI of corroded surfaces is the yoke with a white background paint applied and the worst is by using the overhaul open coil fluorescent ink technique. More work is required but the shot blasted axle surfaces do also seem to have some impact on the sensitivity of the test. Many cracks were identified in the early days of MPI, but cleaning was usually with non abrasive pads and a lot more yoke testing was carried out.

DEFECT DETECTION WITHIN CORRODED AXLE BODY SURFACES CRACKS IDENTIFIED USING A YOKE BUT UNDETECTED WITHIN A COIL ARRANGEMENT USING FLUORESCENT INK

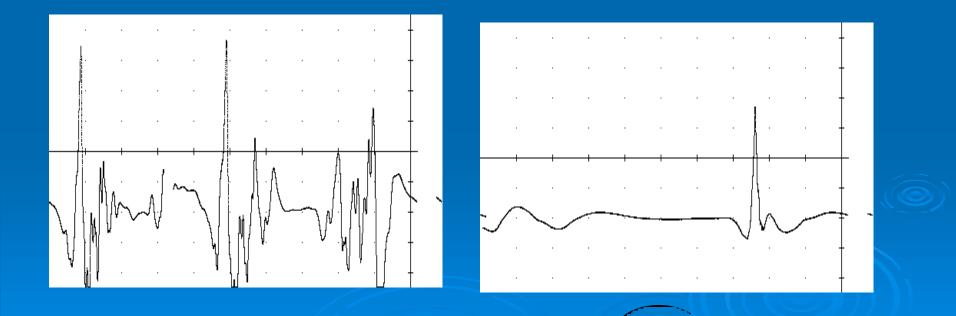
Eddy current response from potash axle cracks 1.5 mm deep & severe surface corrosion noise and crack
0.3 mm deep) on very lightly corroded surface
