# Microstructural analysis of the fractured railway freight car axle

**Z. Odanović**

**IMS Institute, Bulevar vojvode Mišića 43,  
Belgrade, Serbia**

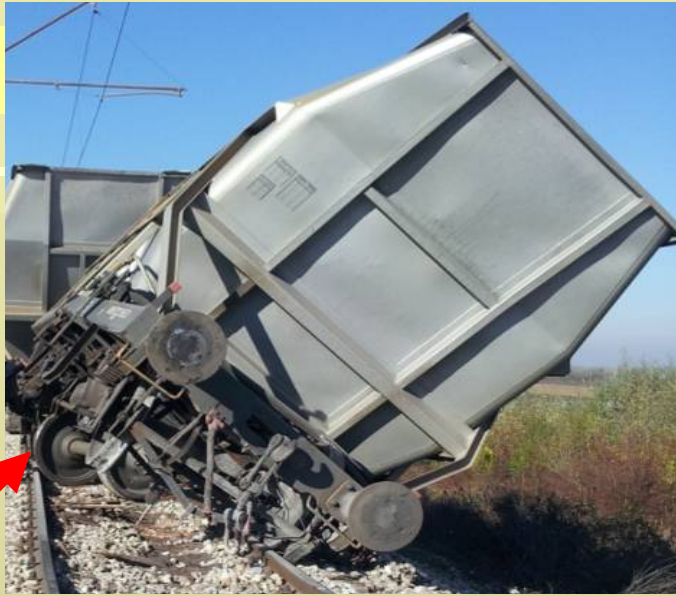
**Fig. 1. Damaged railway freight car**

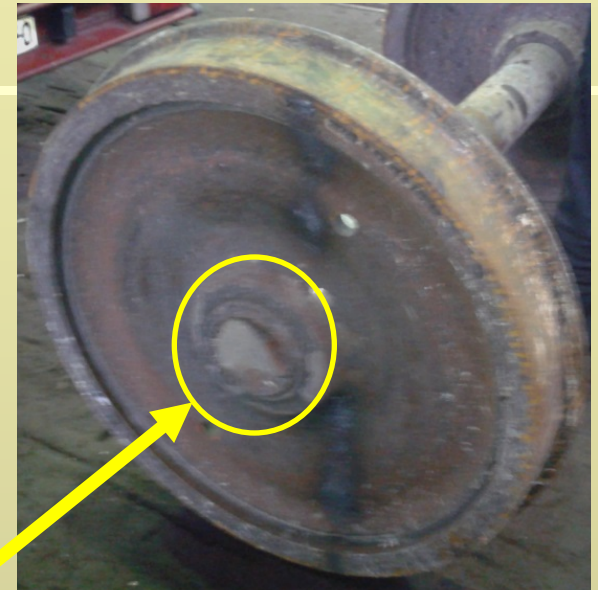
**Axle fracture occurred in the cross-section located between the roller bearing and railway wheel on the transition radius**

**Fig. 2. The railway wheel and axle with signed fractured surface**

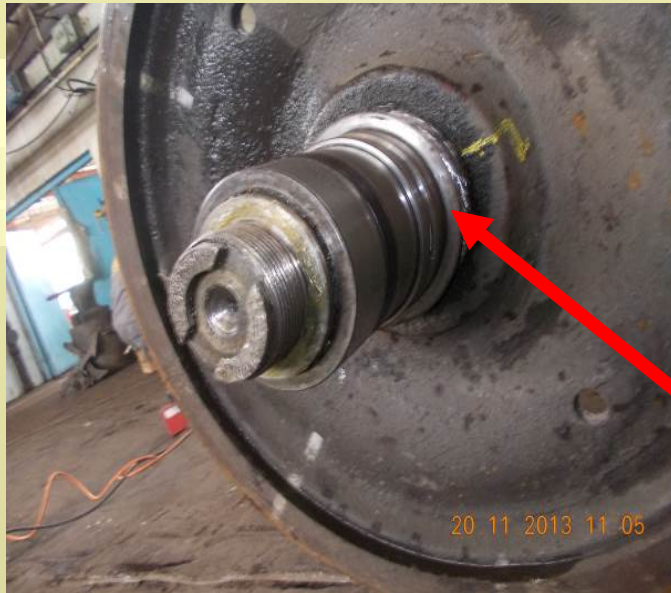
**Fig. 3. Journal on the side of the railway axle where fracture has not occurred**

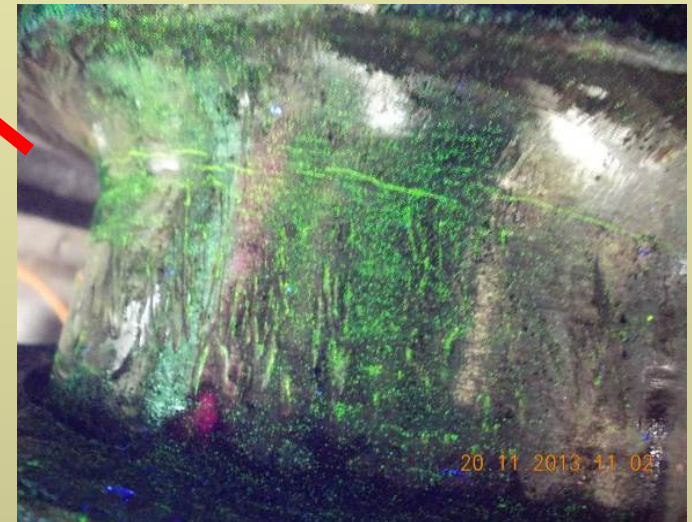
**Fig. 4. Appearance of cracks registered at the source of the stress concentration**

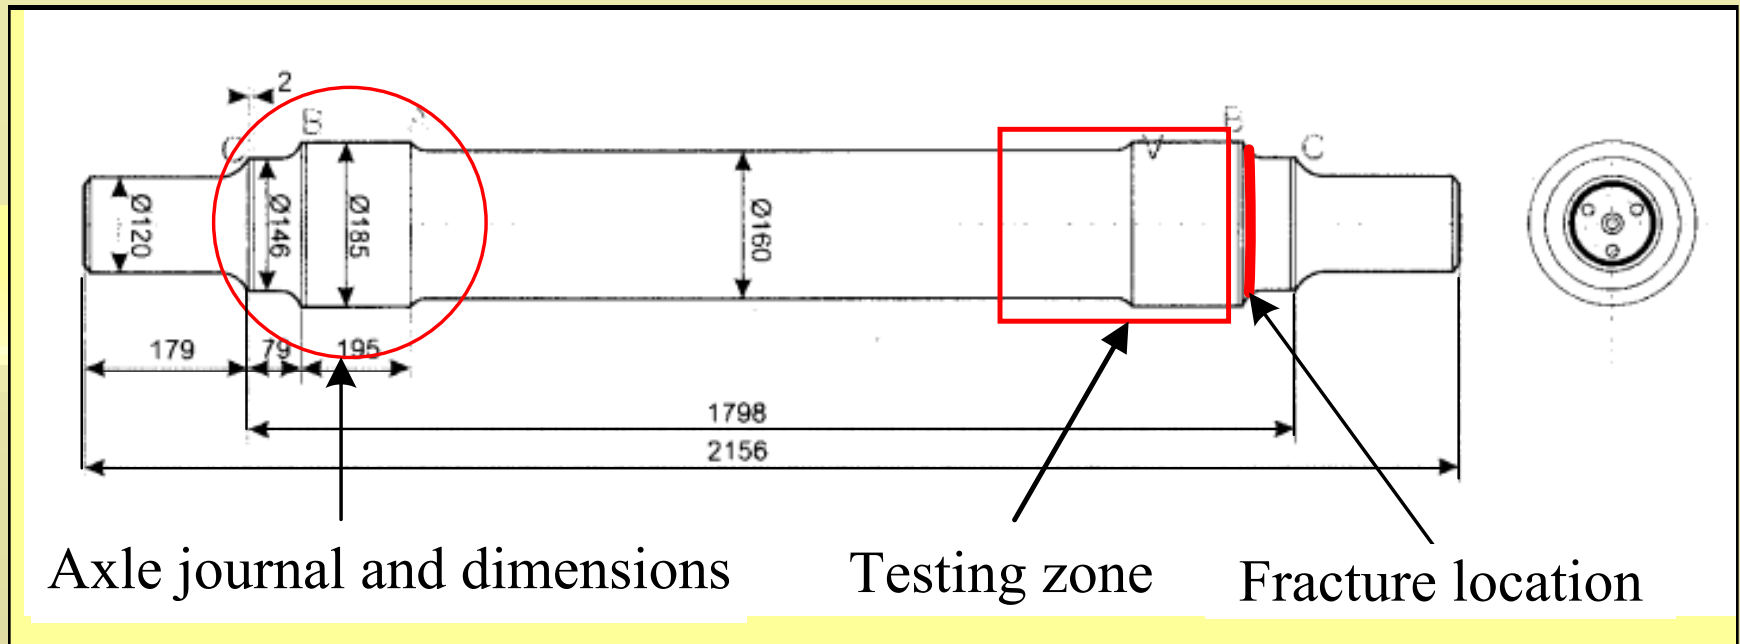
**Fig. 3. Details of the investigated railway axle,**  
 — geometry and dimensions in mm,  
 — fracture location,  
 — tested zone

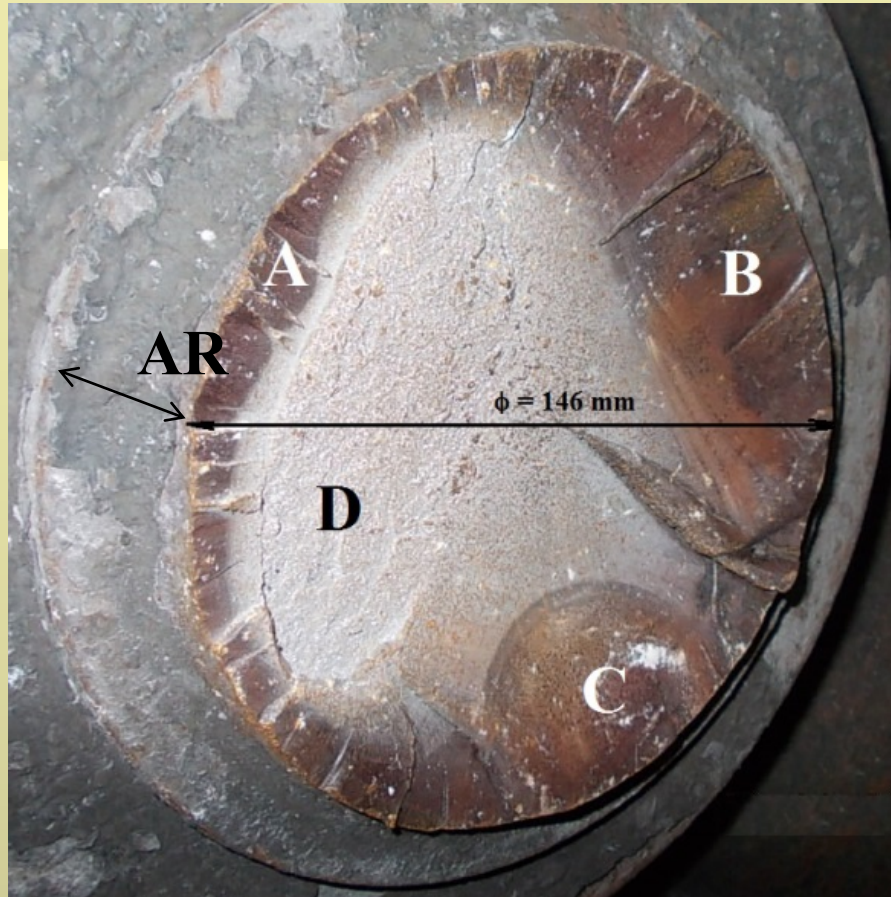
Fig. 4. Fractured axle surface

- Numerous initial cracks on the outer surface of the *critical axle radius AR*.
- Spread parallel to the axle cross section.
- Formed specific shape of *tooth like initial cracks*.
- Presence of corrosion was evidenced.

- Similar in morphology, but different in shape.
- Initialised at the ratchet marks and propagated by the *fatigue mechanism*.
- Highly oxidised which indicates long presence in axle exploitation.

- Final axle fracture, *ductile* in morphology accounts for approx. 30 – 40% of the cross-sectional area.

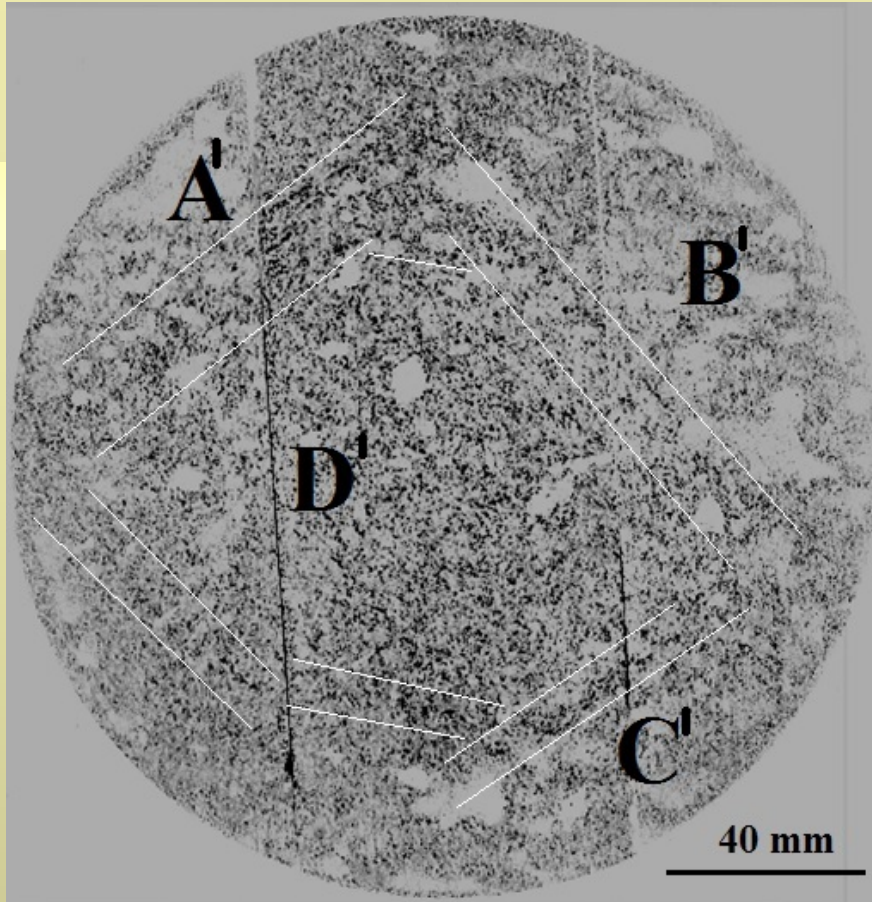
**Fig. 5. Macrostructure of the axle cross section obtained by sulphur print (Baumann method)**

- Small-scale heterogeneities in the central zone of the cross section.
- Dark etching *strings of inclusion* between the marked white lines at the mid radius.
- Comparing, one could notice matching between zones signed as A'-B'-C'-D' and A-B-C-D from Fig.4.

- Initial cracks from the axle surface were propagated through the cross section in the transversal direction, until reaching the strings of inclusions in zone between white lines.
- Orientation of these inclusion is perpendicular to the direction of the cracks propagation, and it could be assumed that represents *barrier* to the further crack propagation in radial direction for some period.

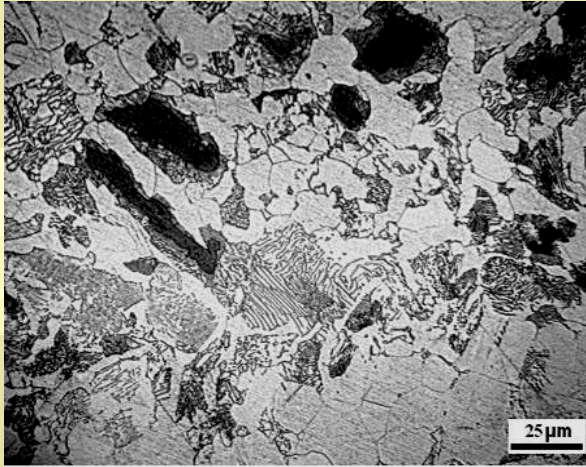
**Fig. 6. Lamellar perlite and ferrite in the axle material microstructure (etched in 3 % Nital)**

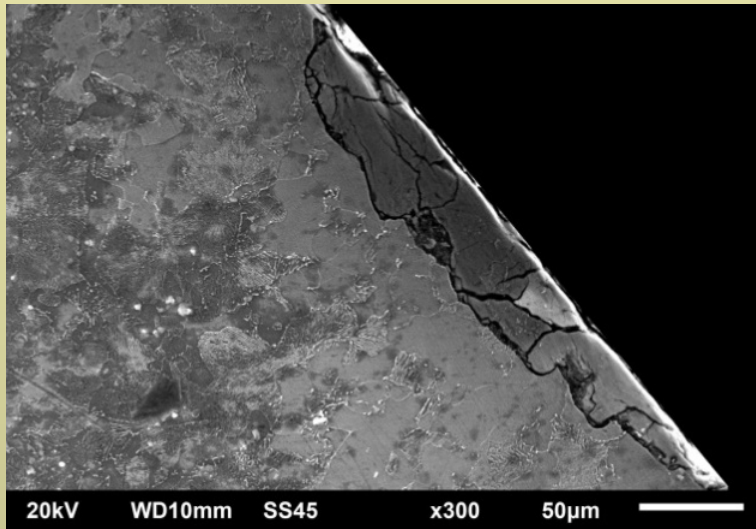
**a) wide, shallow**

**Fig. 7. Corrosion pits in the axle material surface layer in the transition radius zone AR**

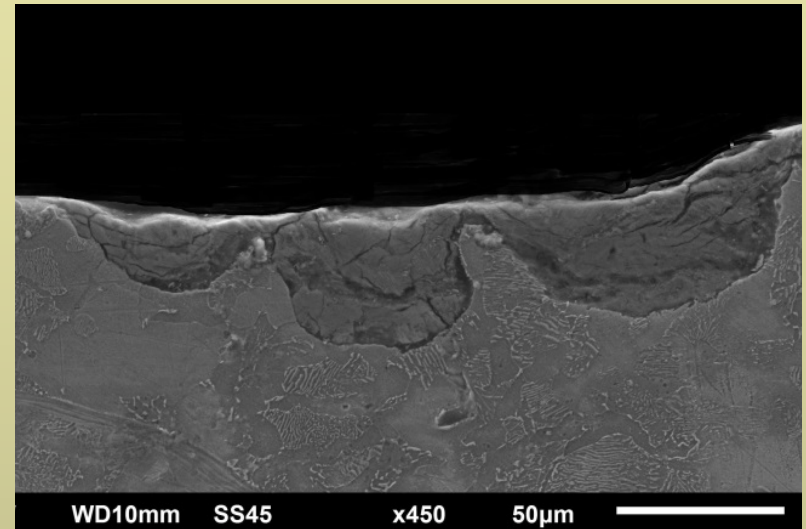
**b) elliptical**

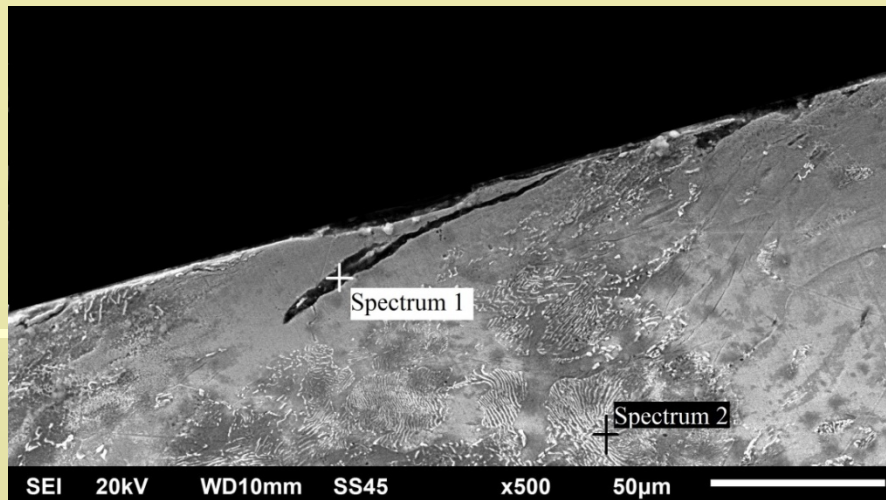
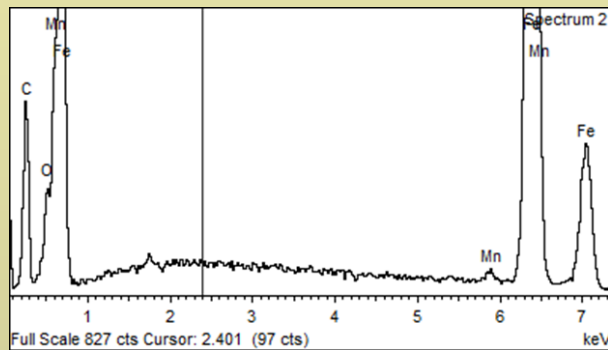
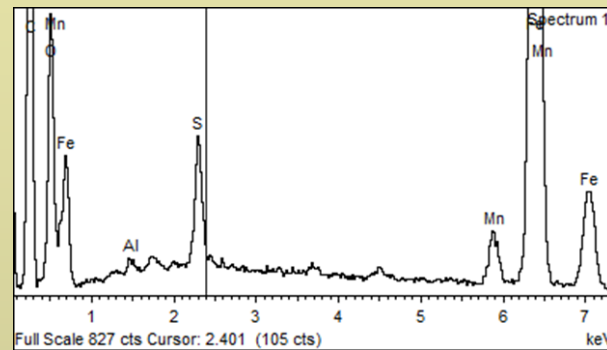
**Fig. 8. Corrosion damage in the material surface layer with subjoined non-metallic inclusions located in a ferritic band**
