**Wolaxim final meeting 24<sup>th</sup>-25<sup>th</sup> October 2012**

**Corrosion fatigue small-scale and full-scale tests**

S. BERETTA, A. LO CONTE

*Politecnico di Milano, Department of Mechanical Engineering*

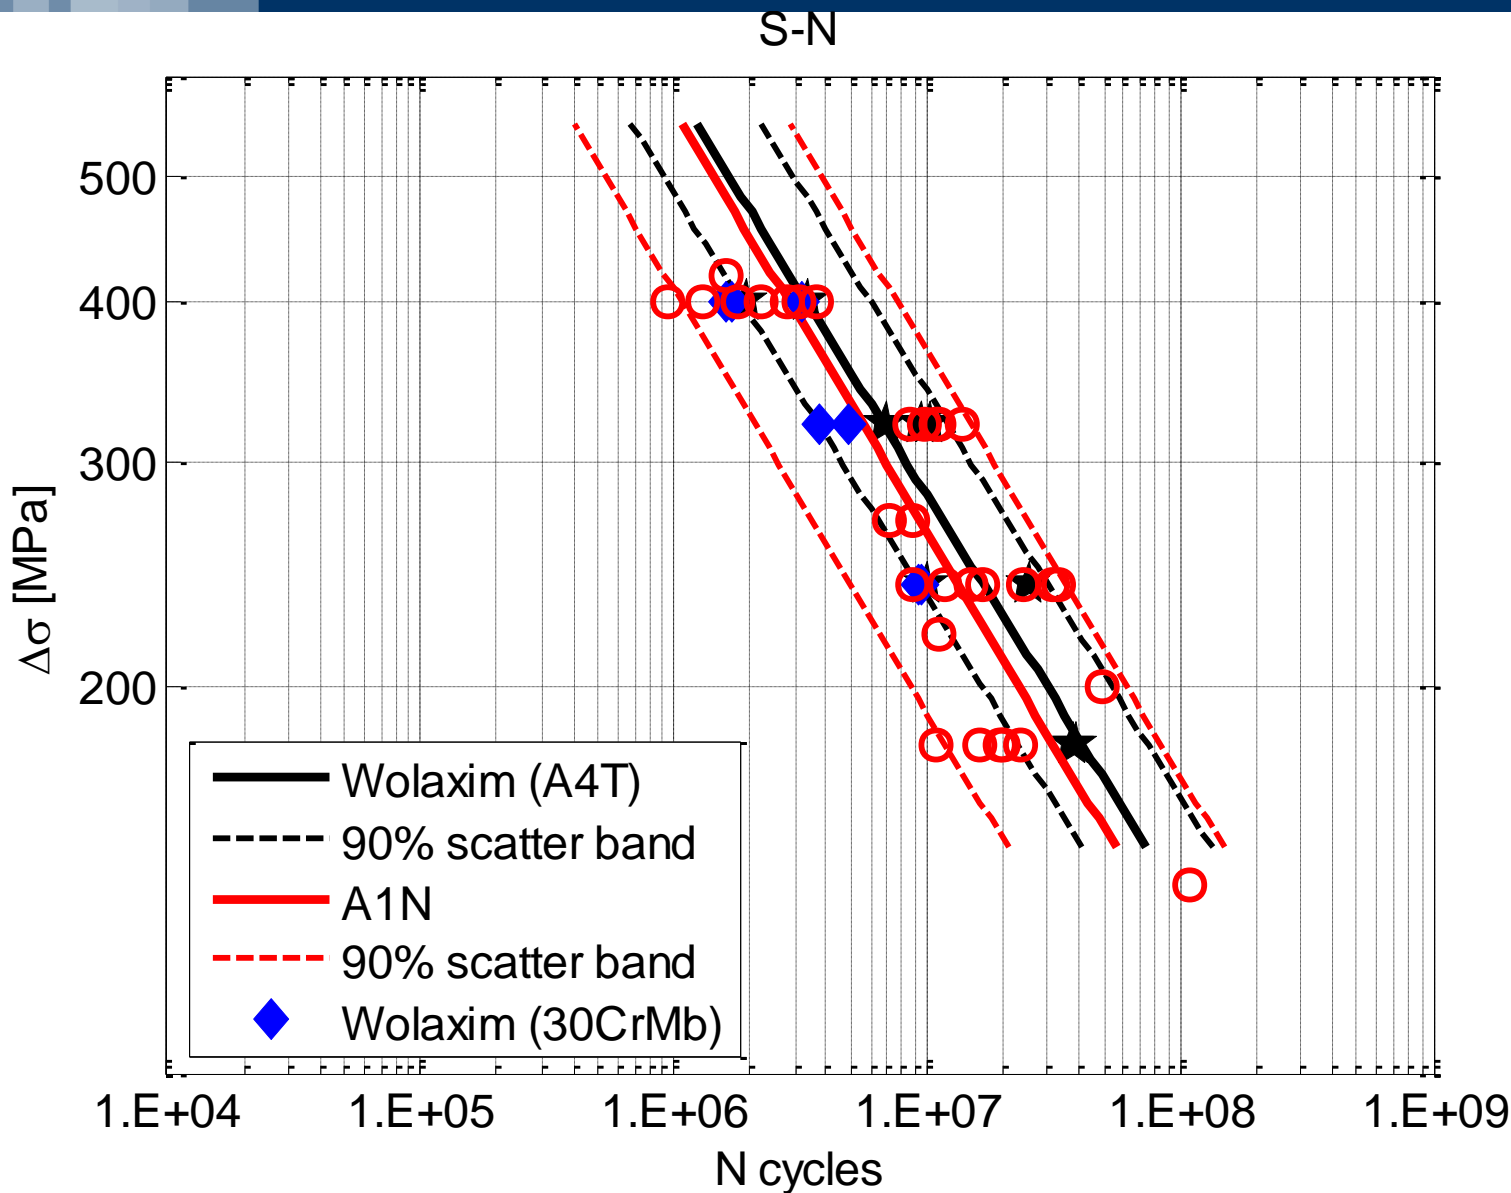
- Atmospheric corrosion has a significant influence on the fatigue life of the investigated materials
- The trend continuously decreasing of the diagram is confirmed for A1N, A4T and 30CrMb steels.
- The presence of rainwater can cause failures at stress levels well below the EN13103/4 design limit ( $\Delta\sigma = 362$  MPa),
- the BASS design limit ( $\Delta\sigma_{\text{design}} = 220$  MPa), which is valid for steels with UTS of 550-650 MPa, is comparable to present experimental results.

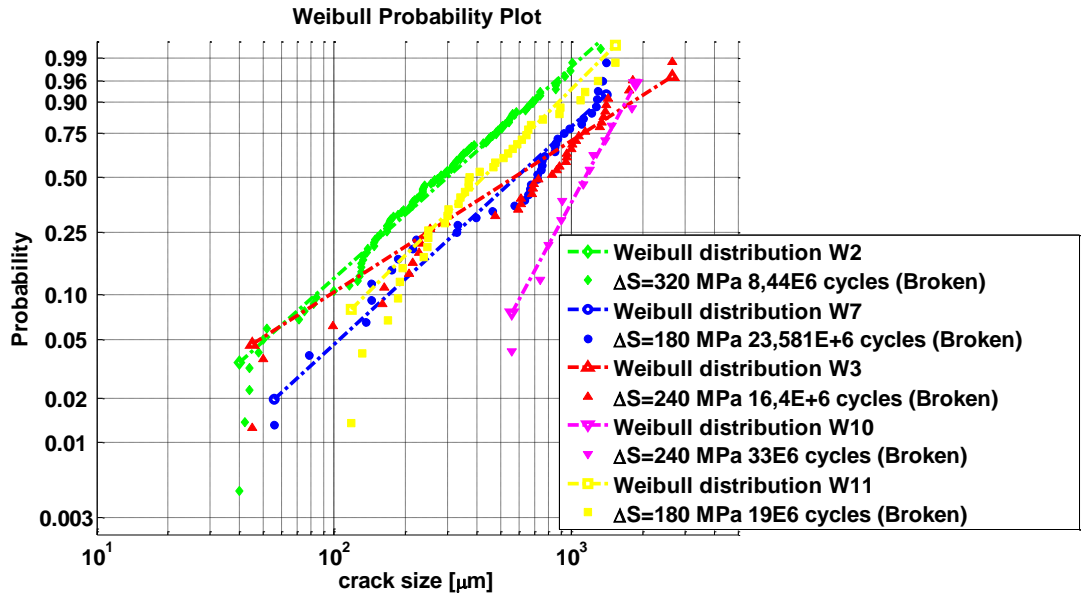
*A1N Specimen W7,  $\Delta S = 180$  MPa. Broken at  $23.6 \cdot 10^6$  cycles*

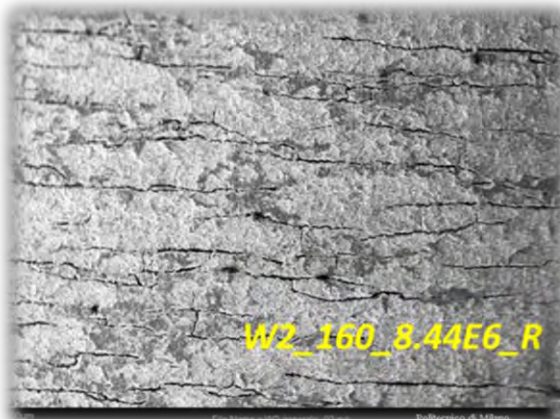
**Specimen W2,  $\Delta S=320$  MPa.  
Broken at  $8.44 \cdot 10^6$**

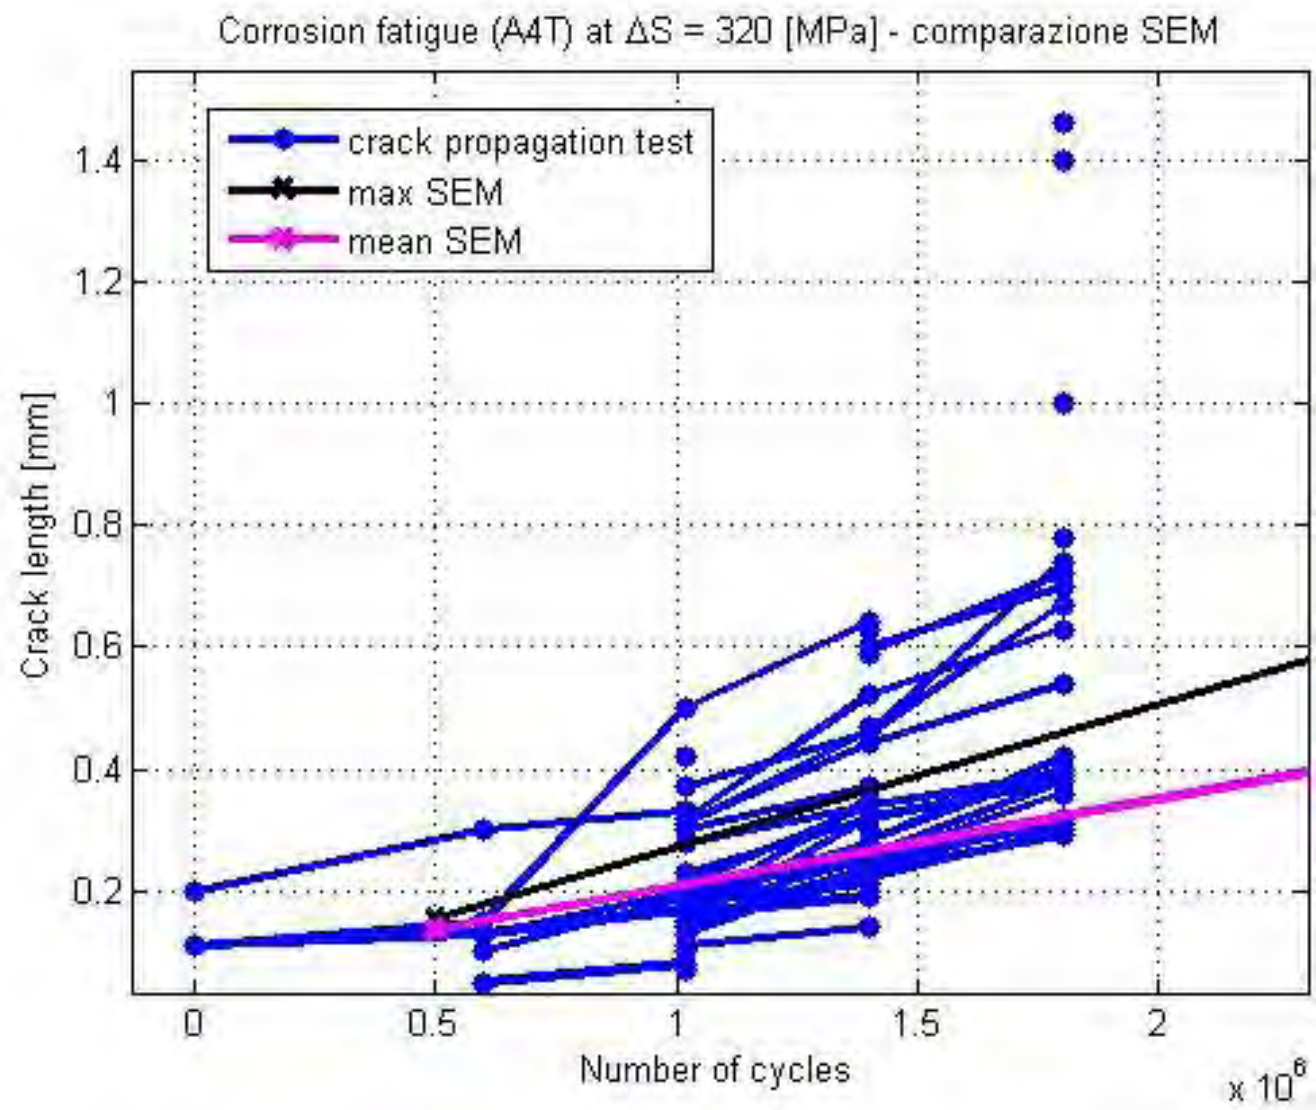
# Propagation of single cracks A4T 320 MPa

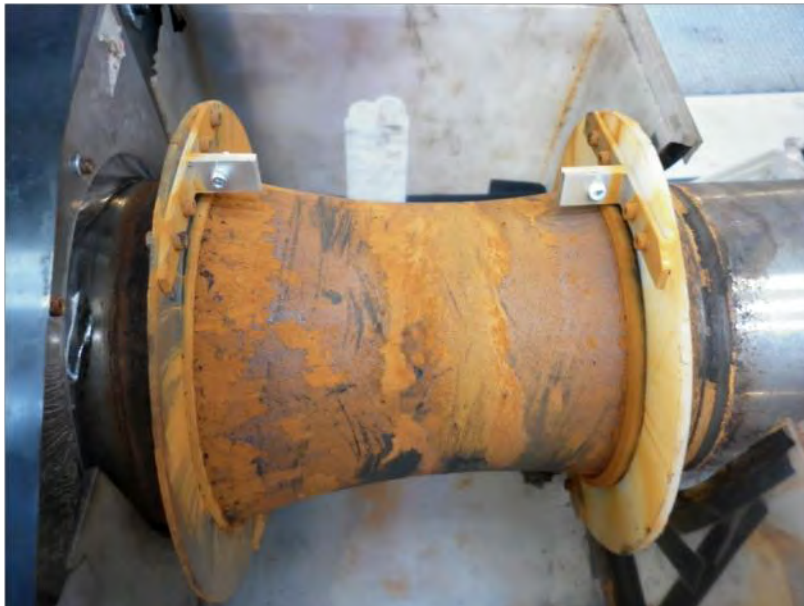
## Mechanical surface cleaning

**Before**

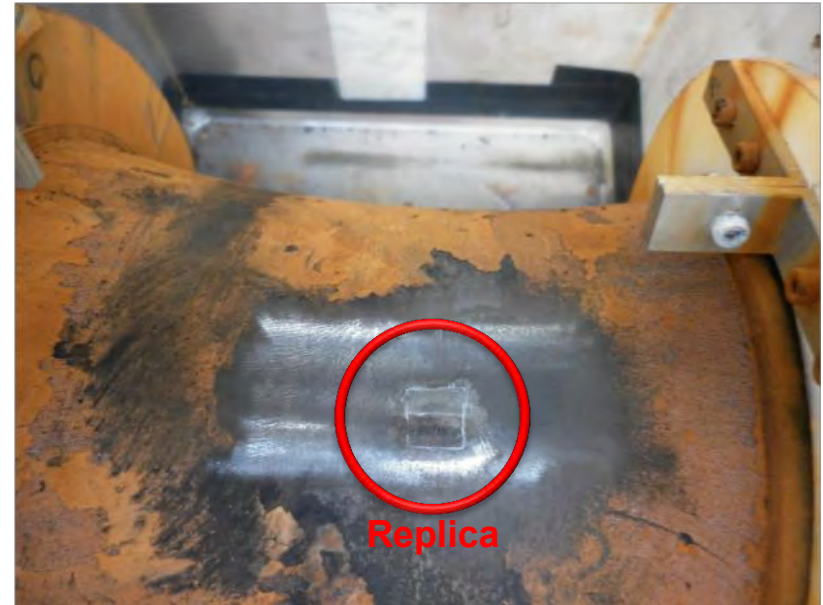
**After**

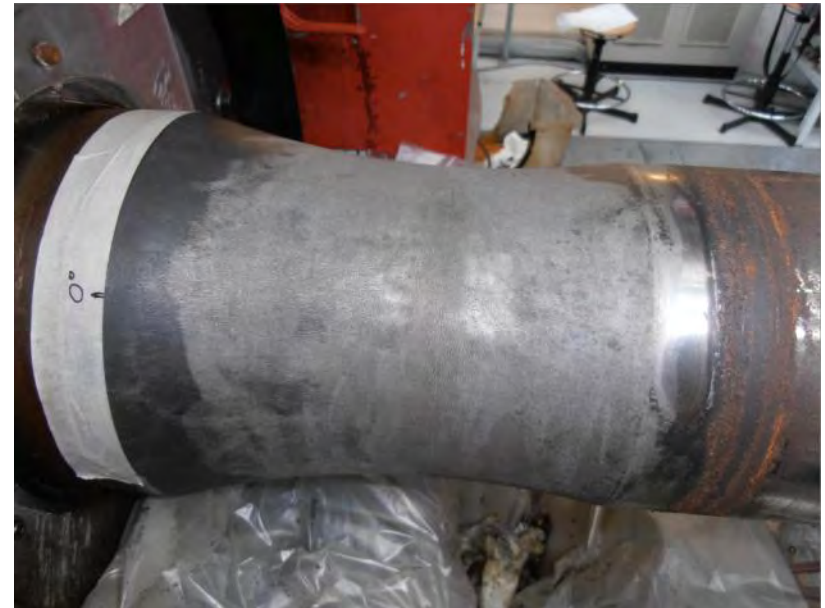
**After chemical cleaning**

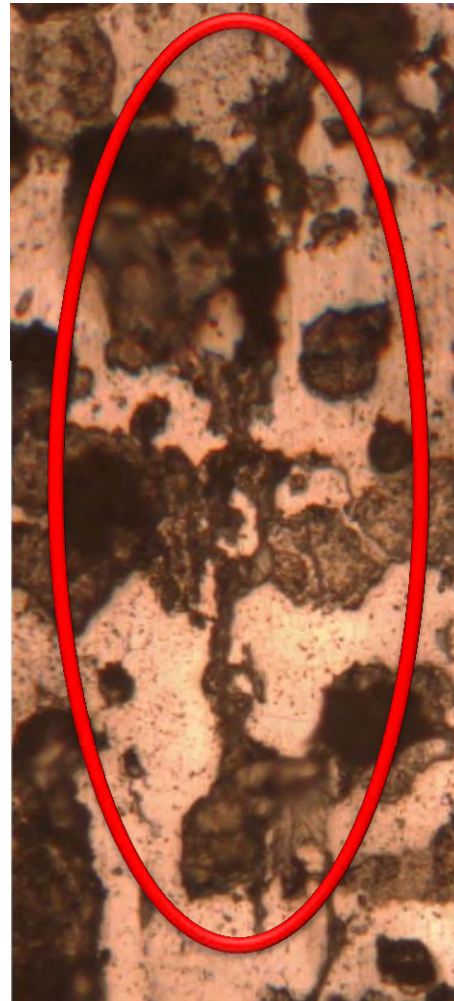
**l = 980  $\mu\text{m}$**

**Plastic replica**

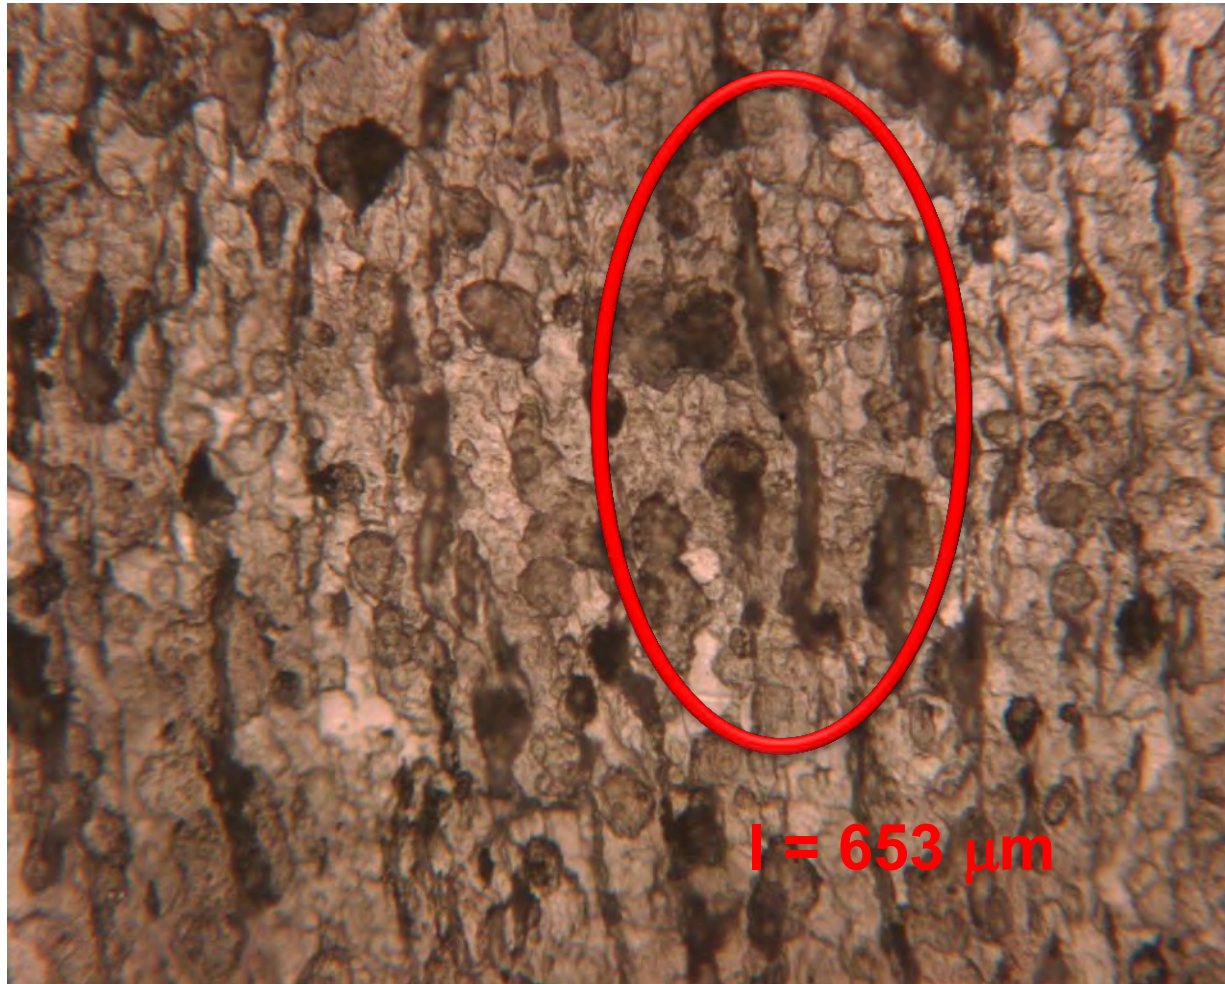
**Small scale specimen, average crack length 1070 micron at 6e6 cycles**
