Assessment of corrosion on rail axles

WOLAXIM Seminar

WOLAXIM Project

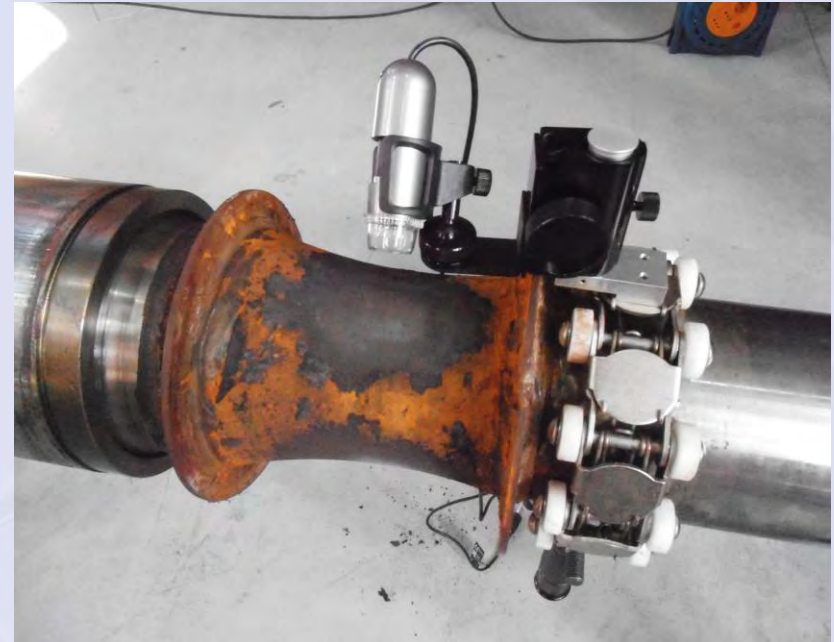
Tests with selected equipment on axles

Picture taken at Polimi for a sample of 2e6 cycles

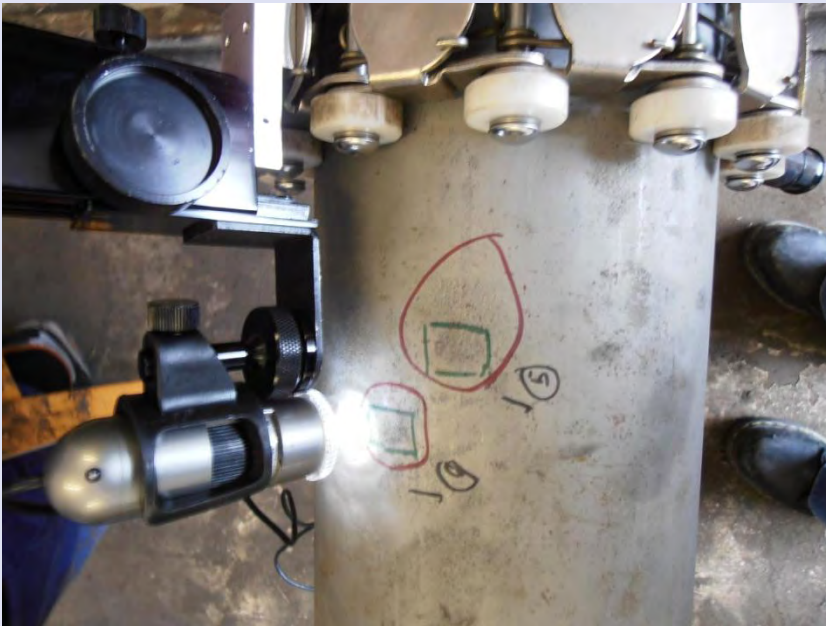
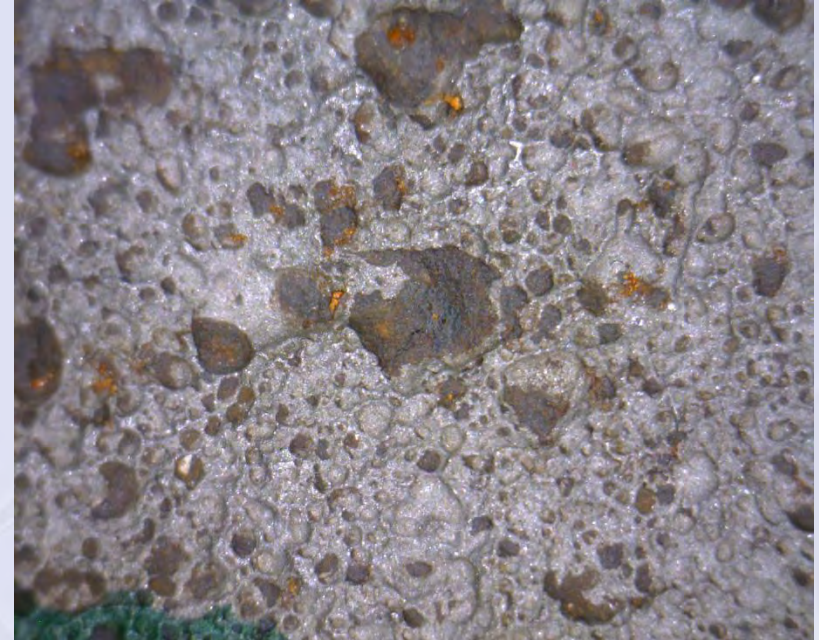
Field trials

Pictures taken in Hamilton of inspected areas on axle (left) and picture of 1.5mm crack in area 9 (right)

- **Process of inspection**
 - Rapid inspection with eddy current array probe
 - Inspection with microscope of regions flagged by EC
 - Inspection of other areas not flagged by EC probe
 - MPI of axle
- **Comparison with other inspection methods**
 - EC array detected defects with length longer than 2mm
 - Microscope could detect all but longer process
 - MPI could only detect defect with length longer than 5mm
