ADVANCES IN: "AXLE DURABILITY ANALYSIS AND  
MAINTENANCE"

## Acceptance of defects at press-fits

Stefano Foletti, Stefano Beretta, Gurer Goksu, Stefano Accarino

## Evaluation of defect acceptability under fretting fatigue on railway axles

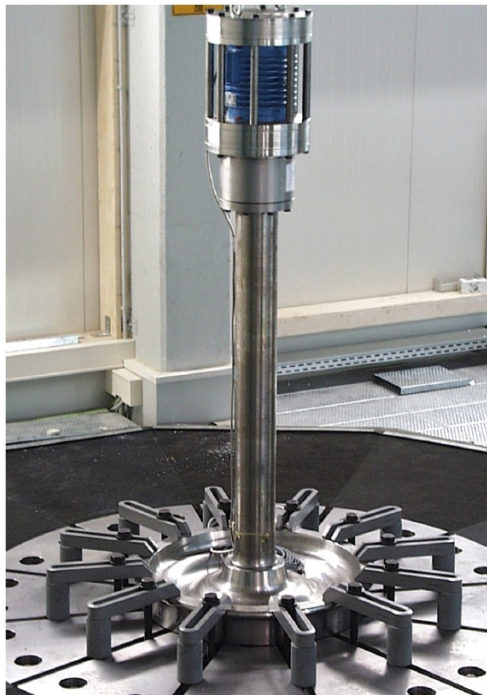
- F1 Geometry with  $D/d = 1.19$  tested by Polimi on Vitry type test rig
- F4 Geometry with  $D/d = 1.12$  tested by SNCF on Vitry type test rig
- F4 Geometry with  $D/d = 1.08$  tested by CAF on Minden type test rig
- F4 Geometry with  $D/d = 1.12$  tested by Deutsche Bahn on Minden type test rig

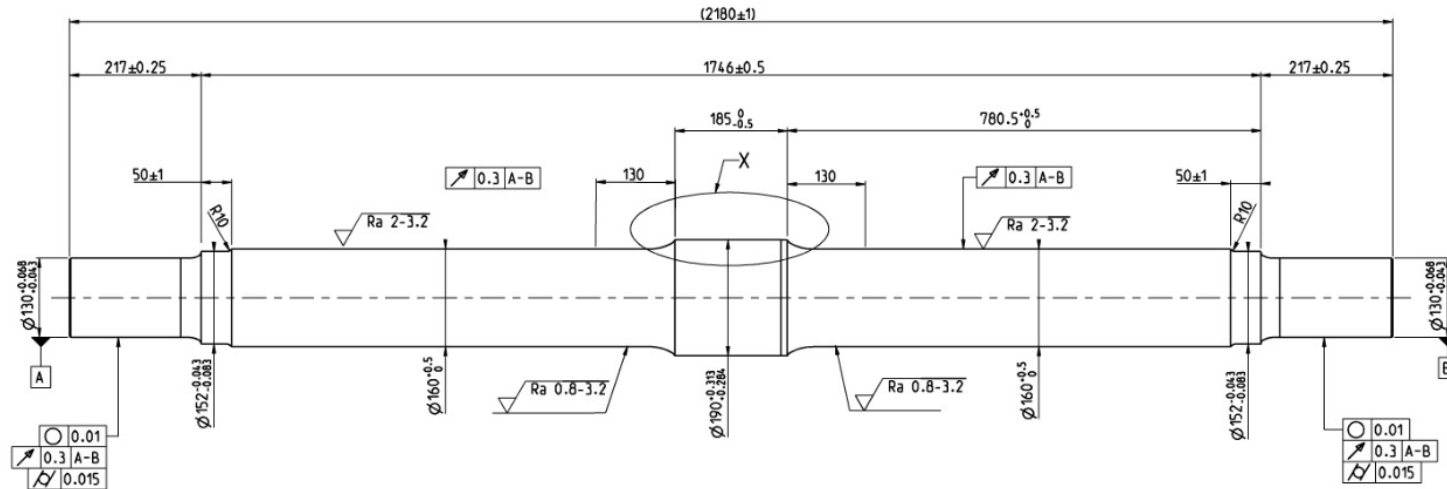
3-point rotating bending tests have been applied on the full scale F1 geometry manufactured from A4T grade steel.

The failure is obtained with a nominal bending stress at the axle's max diameter of 153 MPa. The failure occurred on press-fit seat (ring-axle interface) after  $1.6 \times 10^6$  cycles.

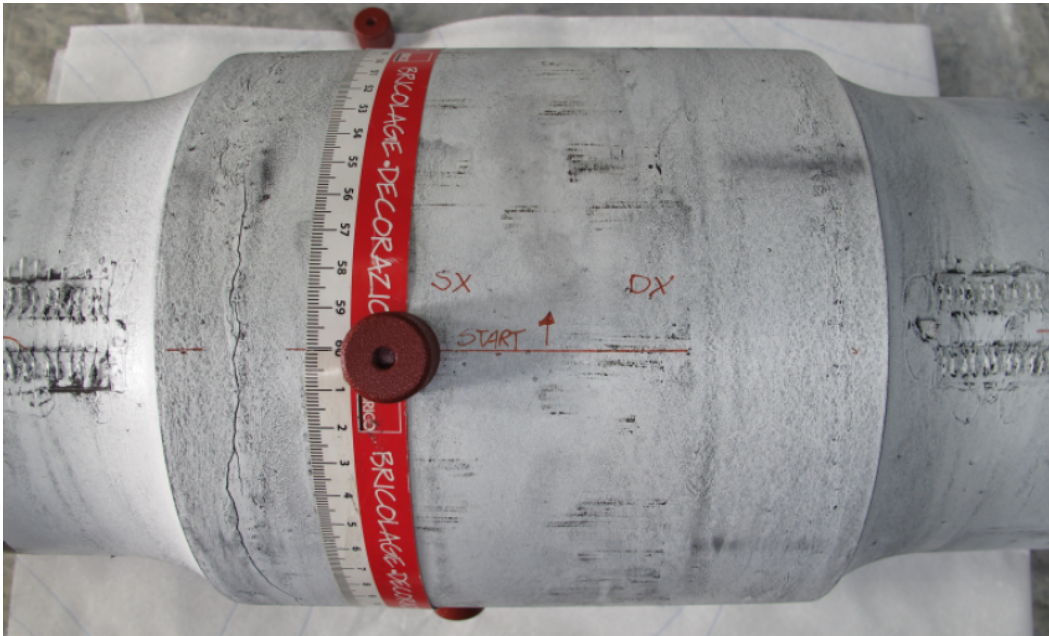
- Presence of a big crack through the whole thickness, at about 20 mm from the border.
- A lot of smaller cracks are evident in the seat, at about 10mm from both the corners

Visual inspection Axle #1, F1 geometry Vitry test type,  
 $\sigma_{\text{nom}} = 153$  MPa.

A lot of smaller cracks are evident in the seat, at about 10mm

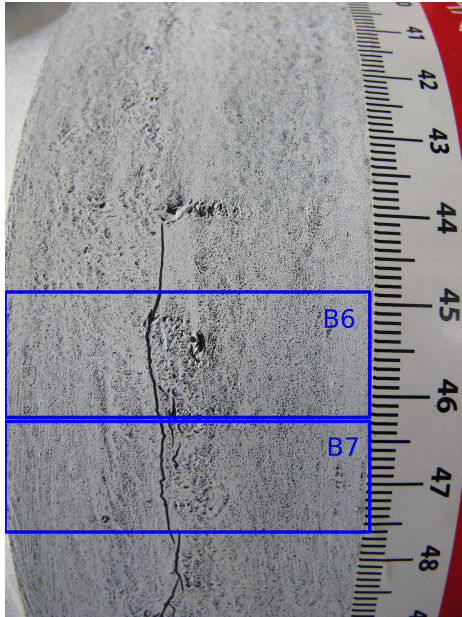
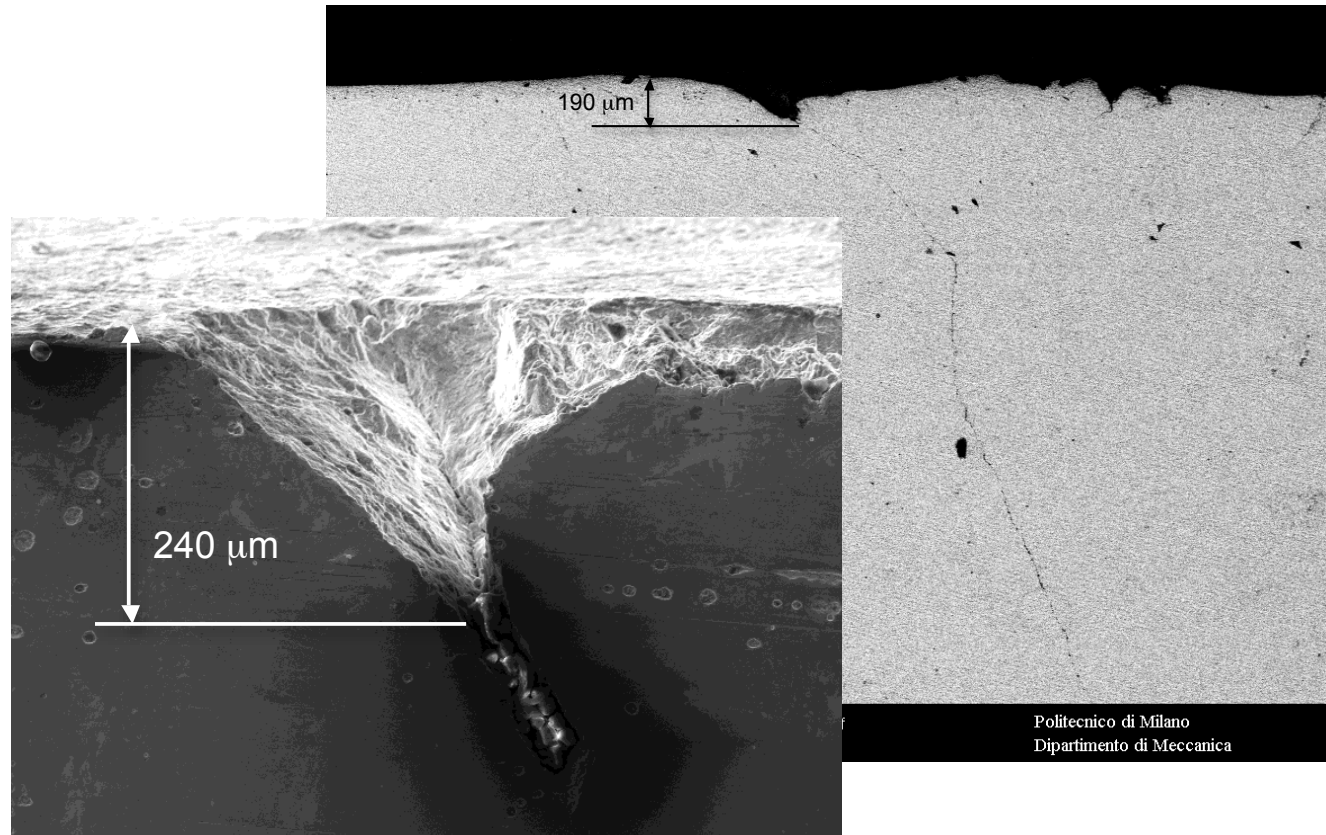
- Fretting damage on material surface has been observed from SEM observation.
- In many cases crack propagation originated from a surface defect has been observed.
- The defect size from which the crack propagates is in the order of 200-250 μm

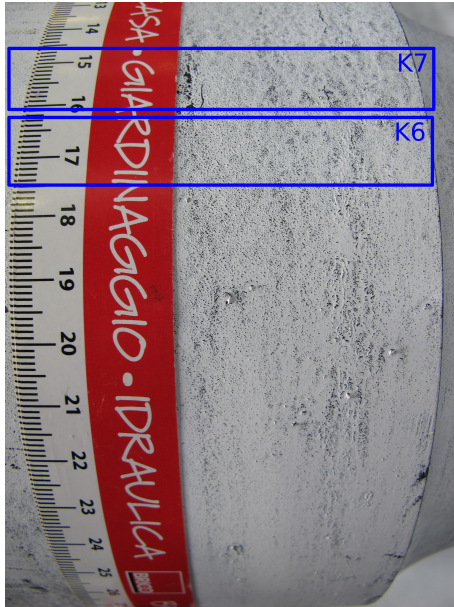
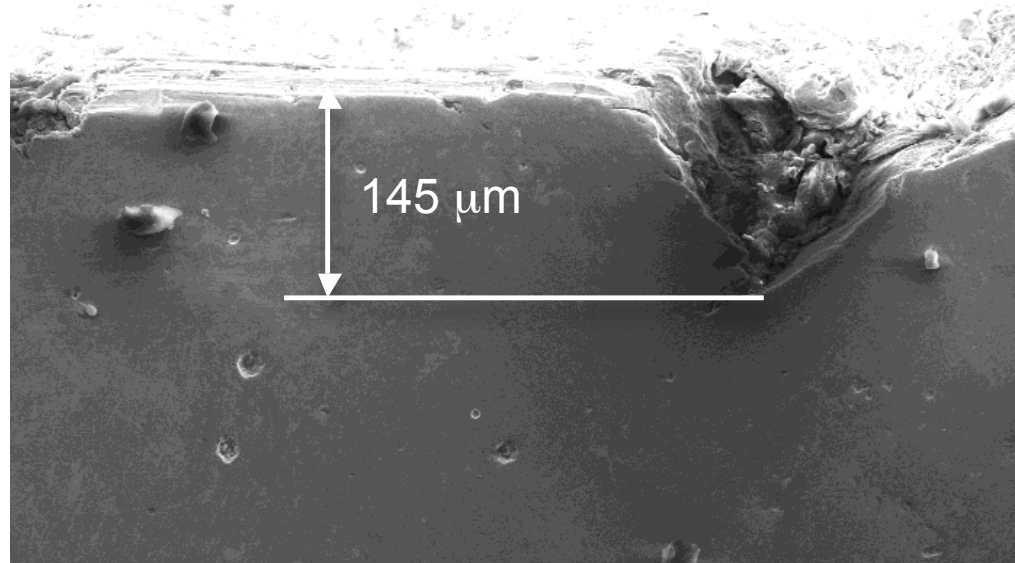
Surface defect with non-propagating cracks

- A lot of non-propagating cracks have been observed. The observed defect depth is in the order of 100-150 μm

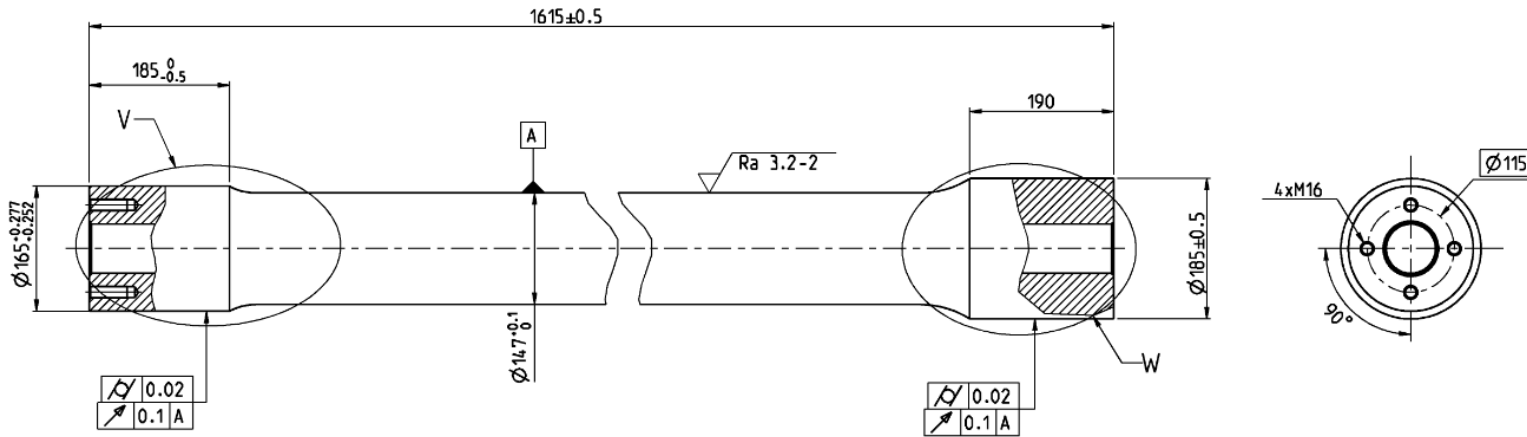
F4 geometry,  $D/d = 1.12$ , Minden type test rig

The nominal stress,  $\sigma_{nom}$ , is the nominal bending stress at the axle's maximum diameter.

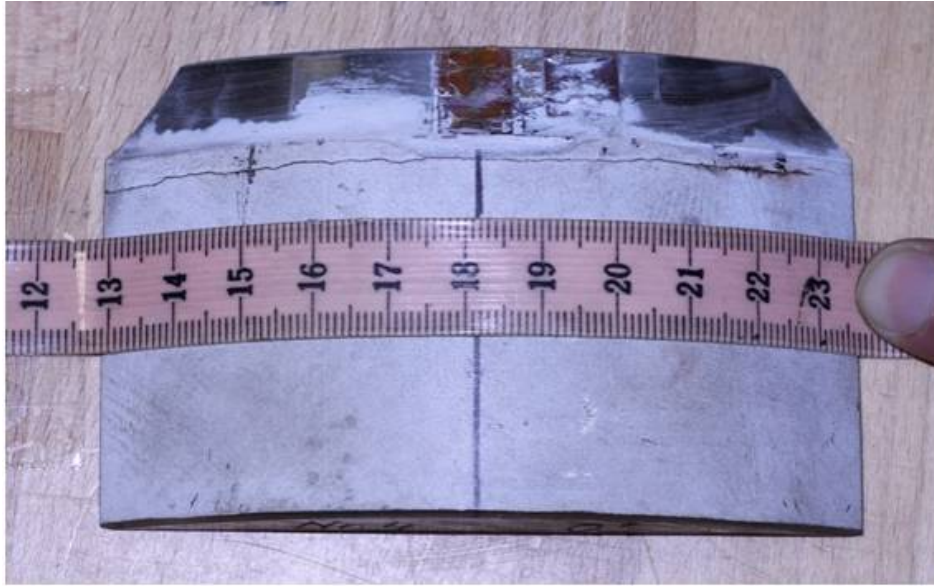
Visual inspection Axle #4, F4 geometry  $D/d = 1.12$  Minden test type,  $\sigma_{\text{nom}} = 126$  MPa.

- The visual inspection revealed the presence of a big crack through the whole thickness, at about 5 mm from the border.
- Some smaller cracks are evident in the seat, at about 2 mm from the fillet

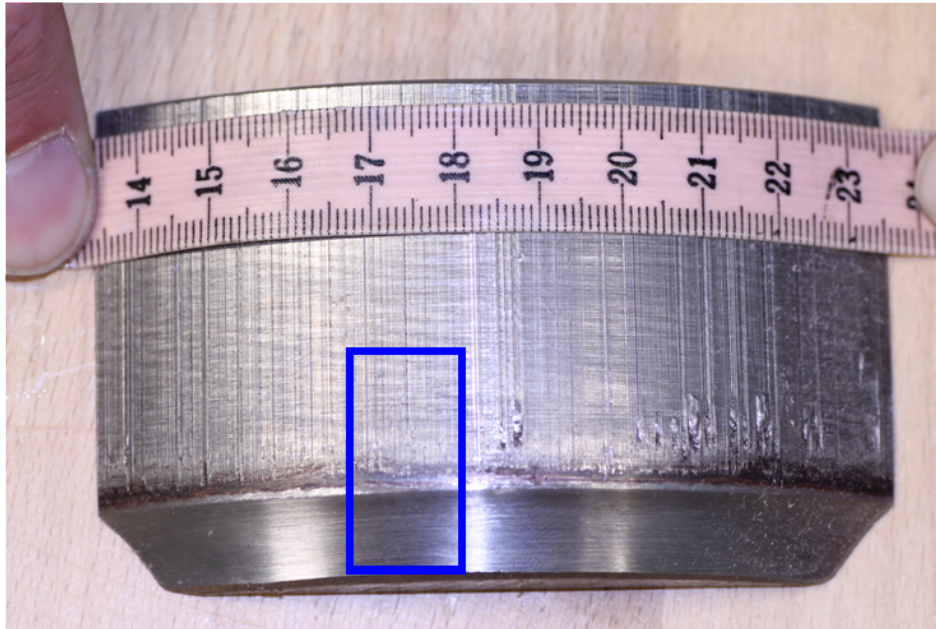
Section detail Axle #3, F4 geometry Minden test type,  $\sigma_{nom} = 120$  MPa

- The run-out axle, Axle #3 tested at  $\sigma_{nom} = 120$  MPa, has been sectioned in order to observe the presence of non-propagating cracks
- The non-propagating cracks are in order of 100-150  $\mu\text{m}$

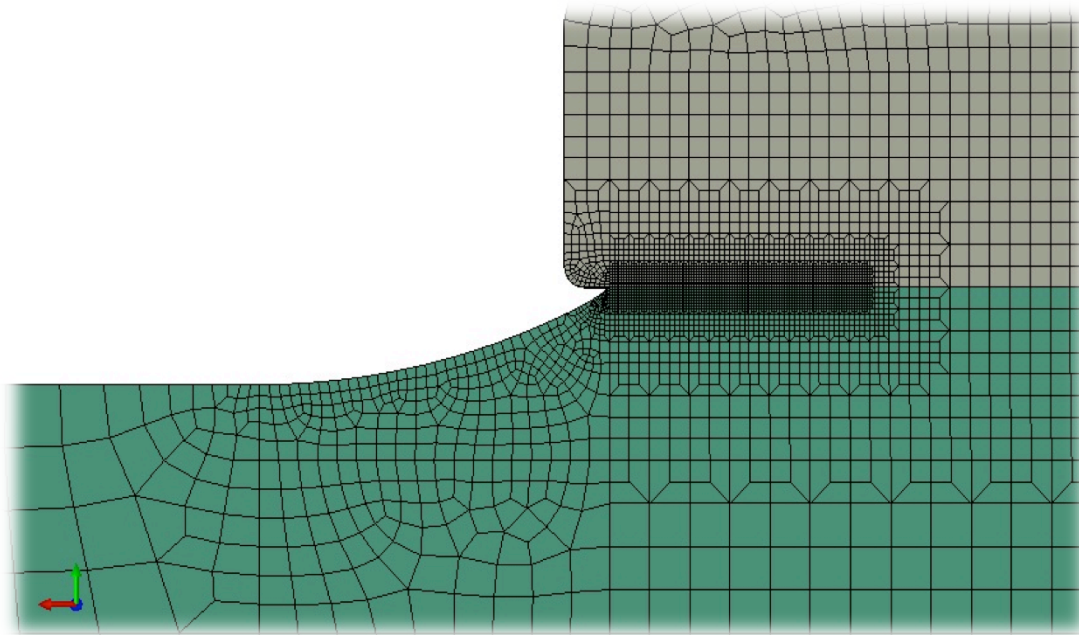
Different FEM analyses have been carried out to simulate experimental tests and obtain the stress path in the critical regions of the shaft.

- The A4T steel has been modelled as linear-elastic using  $E=206000$  MPa and  $\nu=0.3$
- C3D8R elements (8-node linear brick), reduced integration, hourglass control
- In the press fit seat, the element dimension is  $0.25 \times 0.25$  mm
- The interference fit has been applied in the first step, with the use of the maximum value supplied by technical drawings. Tangential behaviour is described with two different friction coefficient: 0.3 and 0.6 respectively

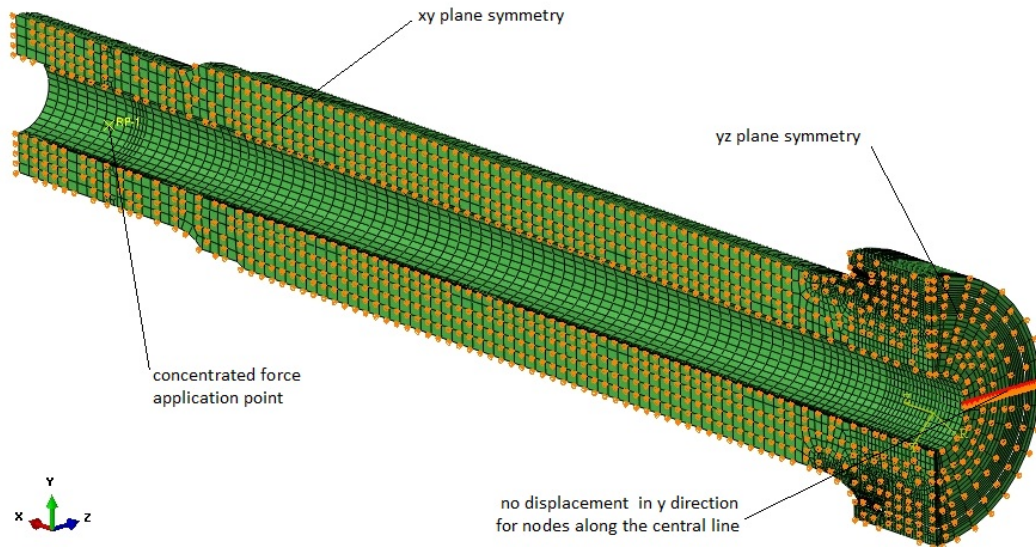
FE model: boundary conditions (Vitry test type)

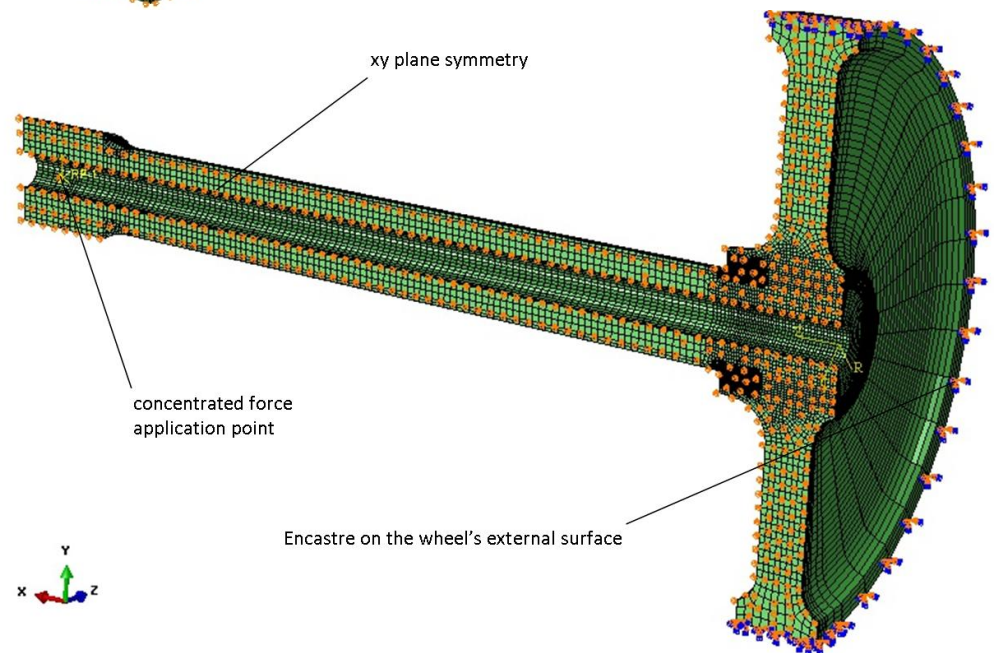
FE model: Boundary conditions (Minden test type)

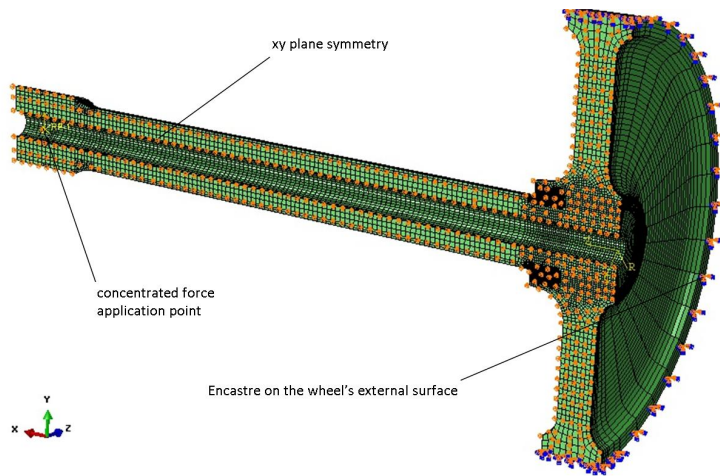
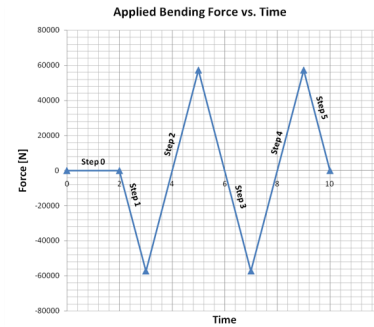
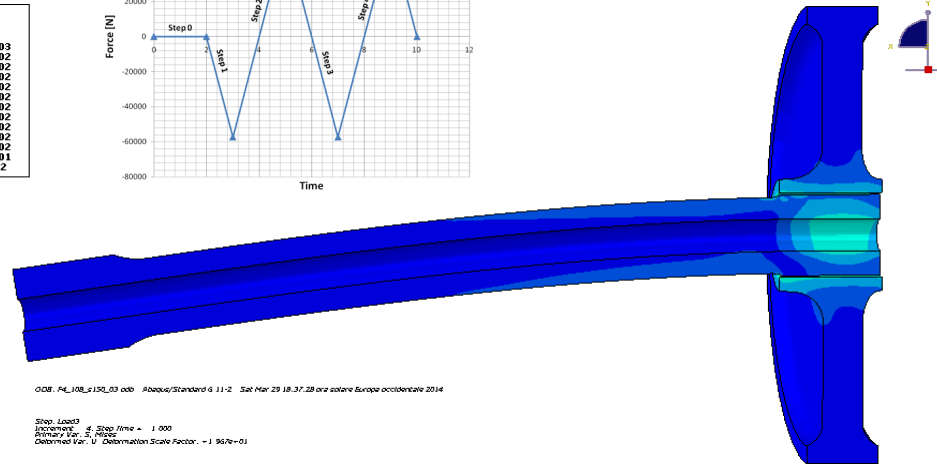
F4 axle,  $D/d = 1.08$ , Minden Type test rig

In order to obtain a stabilized numerical result different steps were processed, carrying out two complete cycles.

The stress path has been extracted from the last cycle in a local reference system

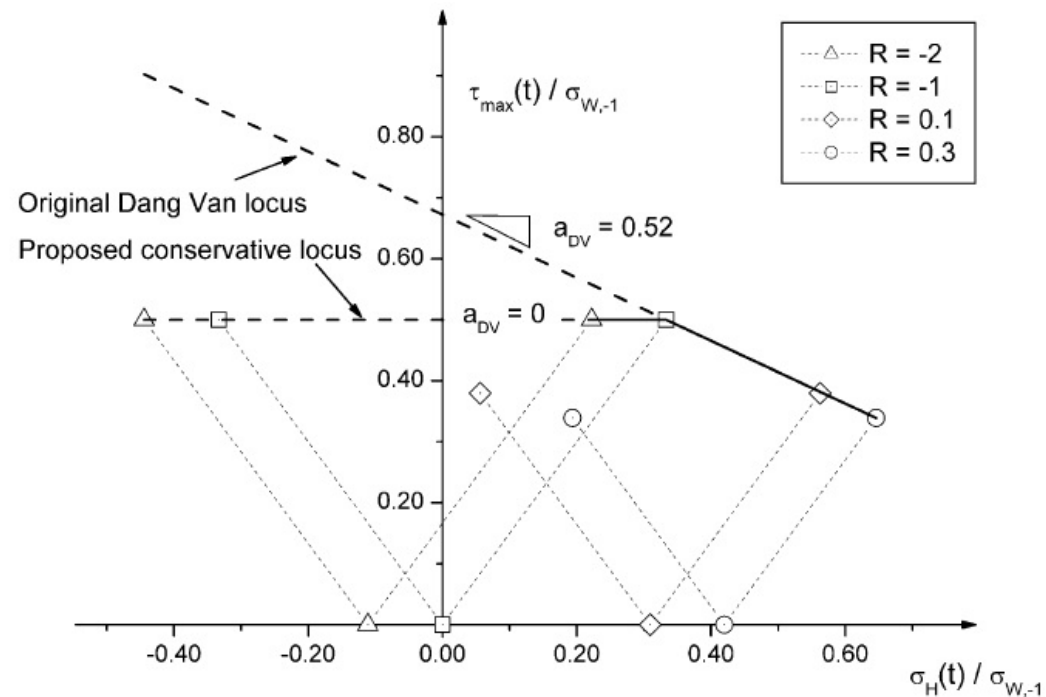
Experimental fatigue tests for a gear steel and a mild railway wheel steel, that have been subjected to out-of-phase multiaxial fatigue loading, have demonstrated that the multiaxial fatigue limit does not depend on hydrostatic stress if  $\sigma_h < 0$

For  $\sigma_h < 0$  a conservative locus has been proposed:

As reported in Figure the Dang Van criterion with the original locus gives a very non-conservative prediction

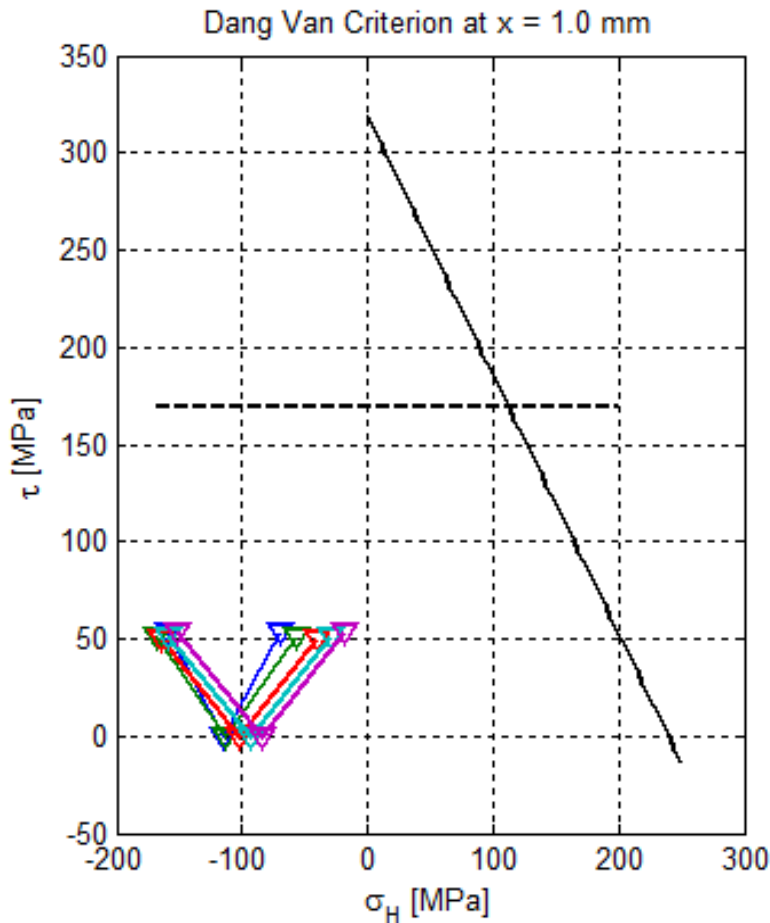
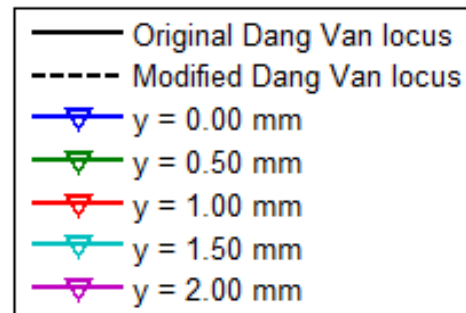
- Hydrostatic vs. Shear stress path for a specific test (F4 Minden test type,  $D/d = 1.08$ ,  $\sigma_{nom} = 150$  MPa, friction coefficient 0.3)
- **No failure is expected if the fatigue limit of material without defects is considered**

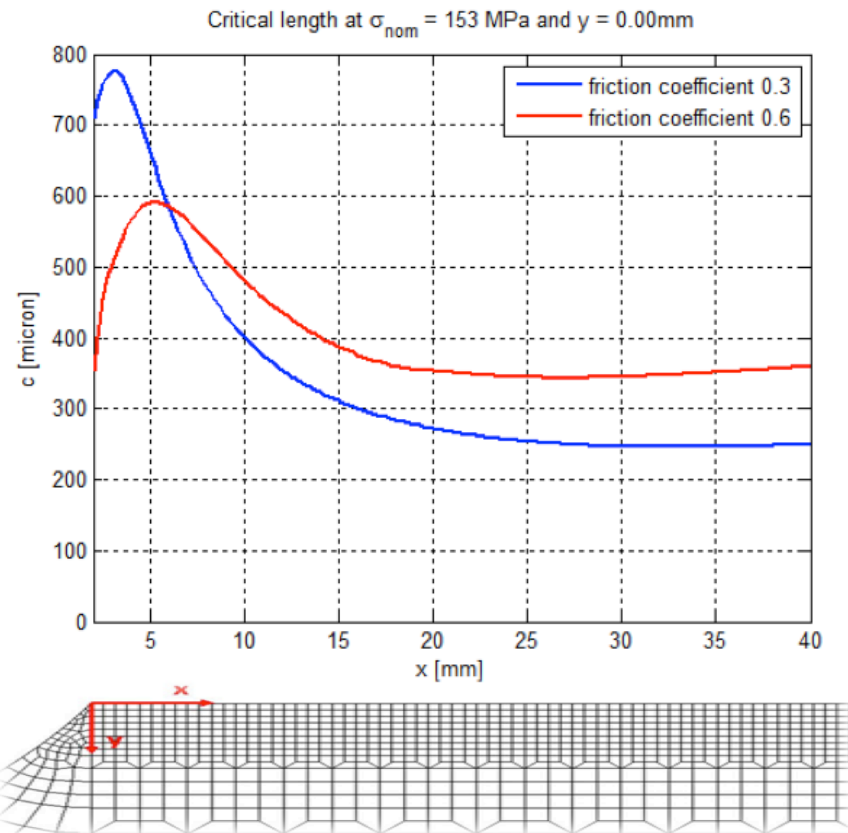
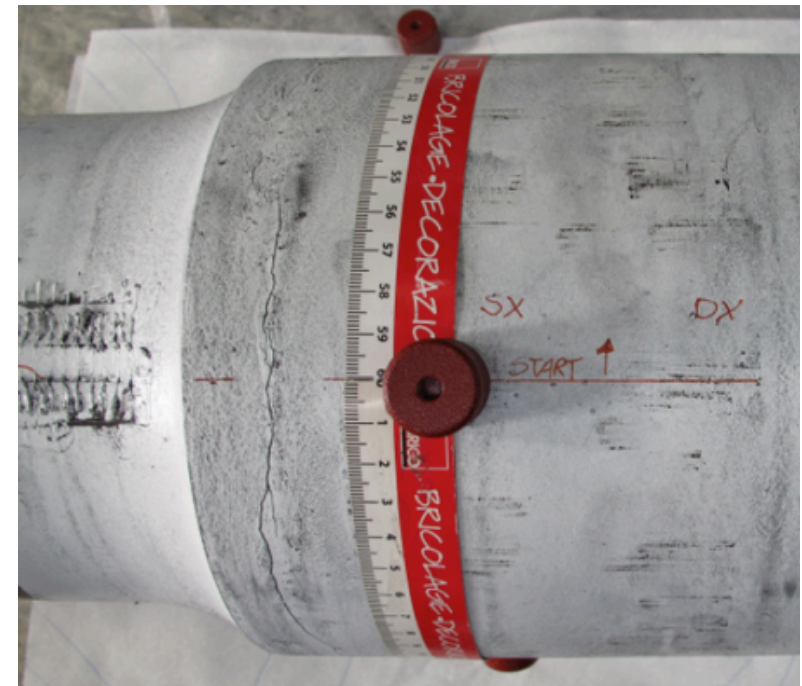
F1 (D/d = 1.19) Vitry test	$\sigma_{nom} = 153$ MPa (failure)	Critical position along x
Analytical results	friction coefficient = 0.3	25 - 35 mm
	friction coefficient = 0.6	20 - 30 mm
Experimental results		20 mm

Failure location  
 $x = 20-25$  mm

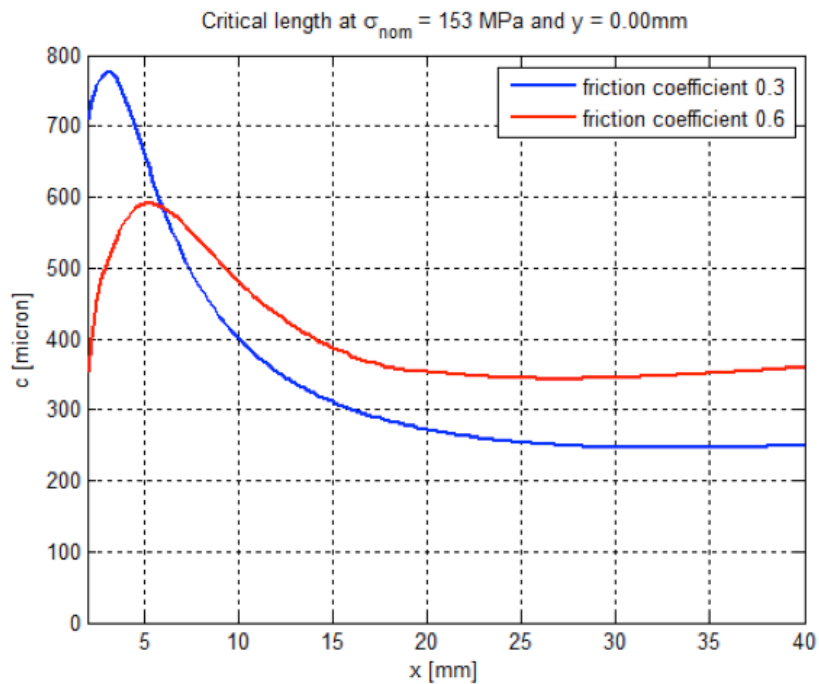
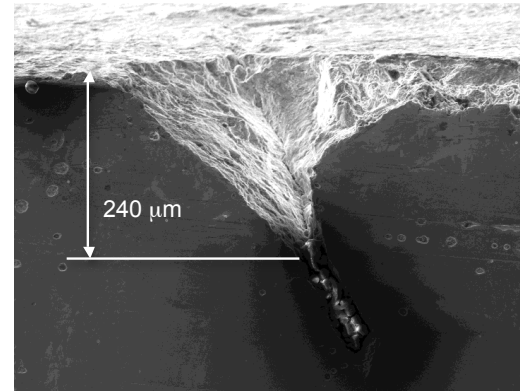
Propagating cracks from a defect of  $240 \mu\text{m}$  at  $x = 25 \text{ mm}$

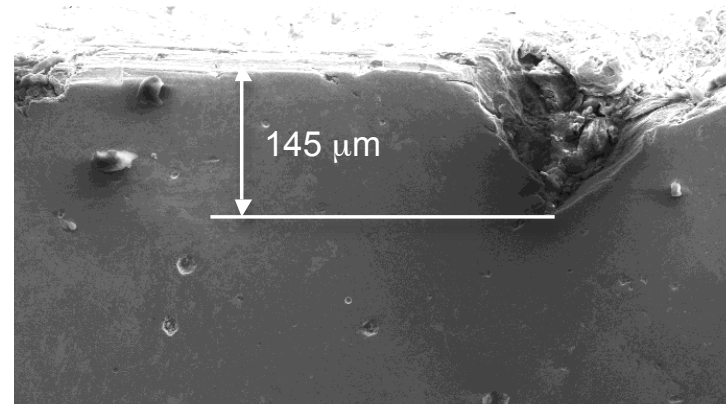
Surface defect with non-propagating cracks

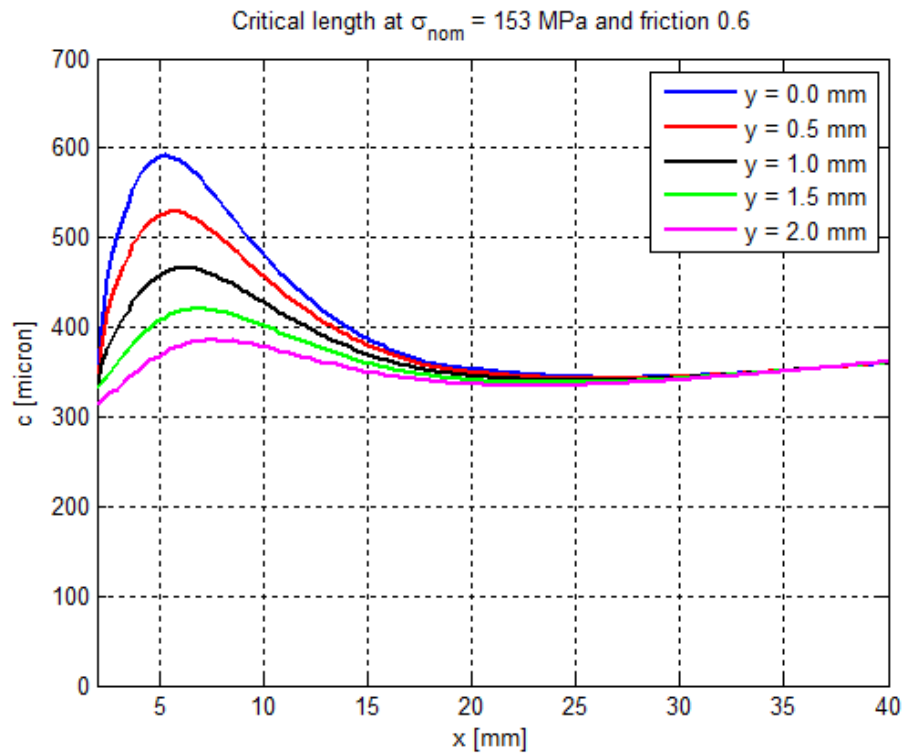
The minimum value of defect size is not affected by the position under the contact surface (y coordinate).

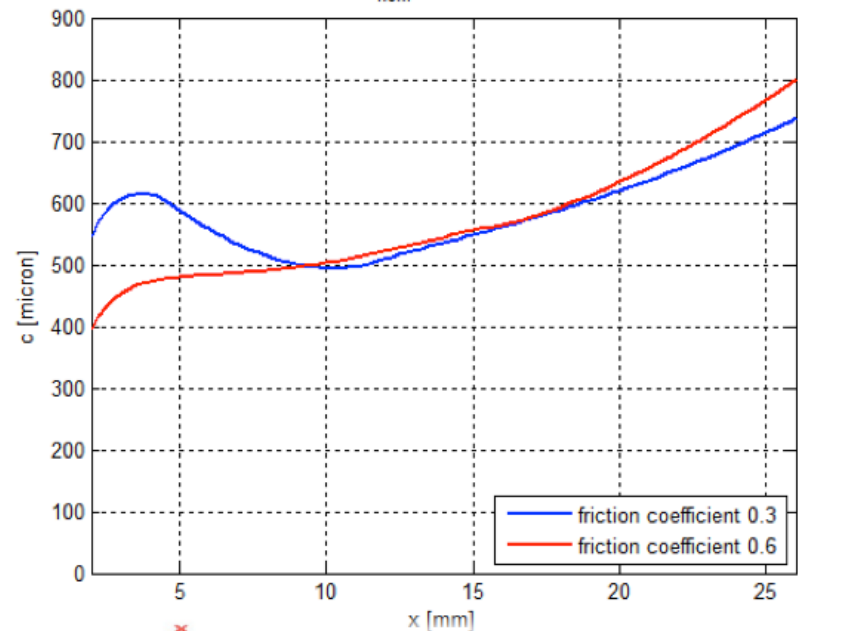
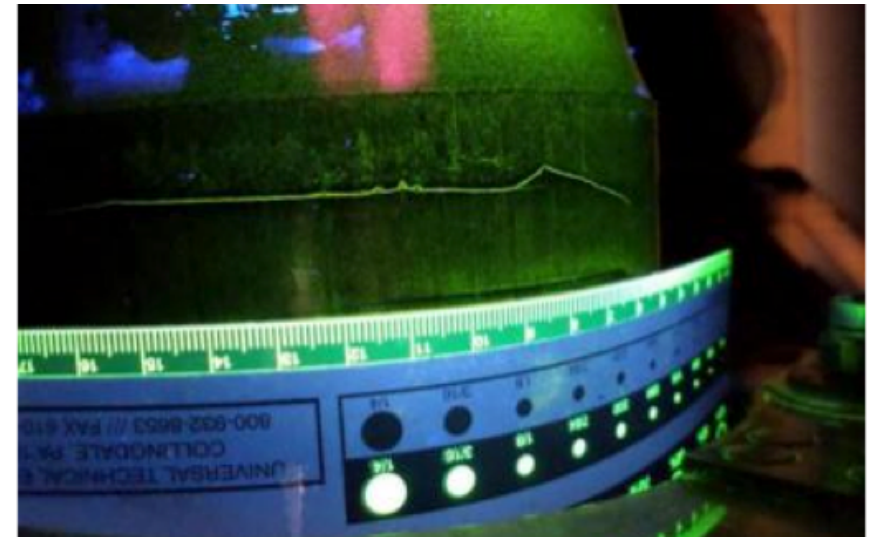
Critical length at  $\sigma_{nom} = 132$  MPa and  $y = 0.00$ mm

Failure location  
 $x = 10-15$  mm

F4 (D/d = 1.12) Vitry test			Critical position along x
Analytical results	$\sigma_{nom} = 120$ MPa	friction coefficient = 0.3	5 - 15 mm
	$\sigma_{nom} = 120$ MPa	friction coefficient = 0.6	3 - 8 mm
	$\sigma_{nom} = 132$ MPa	friction coefficient = 0.3	7 - 15 mm
	$\sigma_{nom} = 132$ MPa	friction coefficient = 0.6	3 - 8 mm
Experimental results	$\sigma_{nom} = 120$ MPa		10 mm
	$\sigma_{nom} = 132$ MPa		15 mm

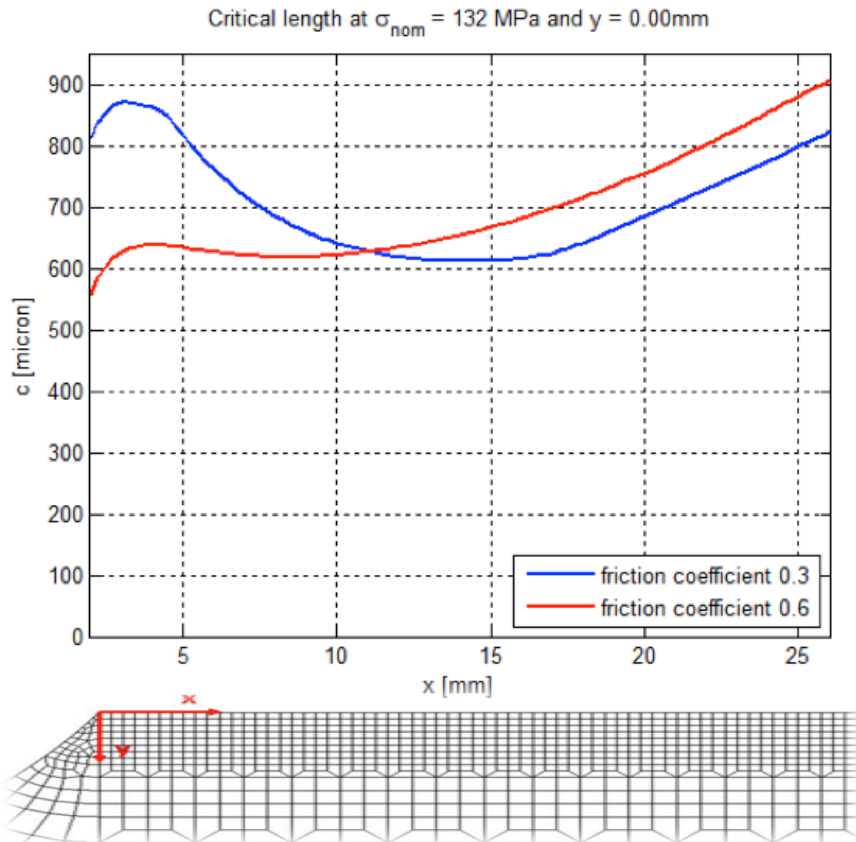
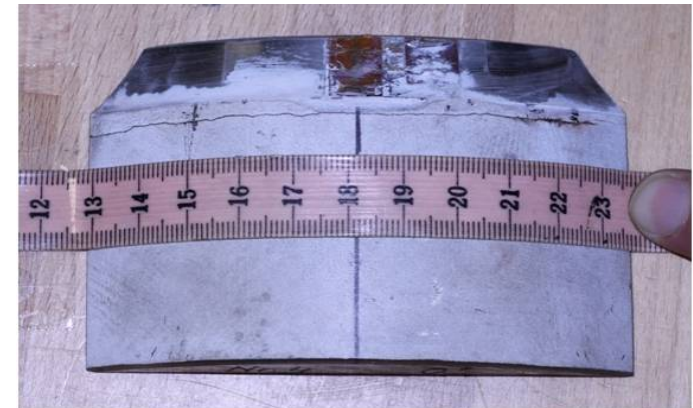
F4 ( $D/d = 1.12$ ) Minden test			Critical position along x
Analytical results	$\sigma_{nom} = 132$ MPa	friction coefficient = 0.3	12 - 18 mm
	$\sigma_{nom} = 132$ Mpa	friction coefficient = 0.6	4 - 12 mm
Experimental results	$\sigma_{nom} = 126$ Mpa		5 mm
	$\sigma_{nom} = 132$ Mpa		4 mm

Failure location  
 $x = 5$  mm ( $\sigma = 132$  MPa)

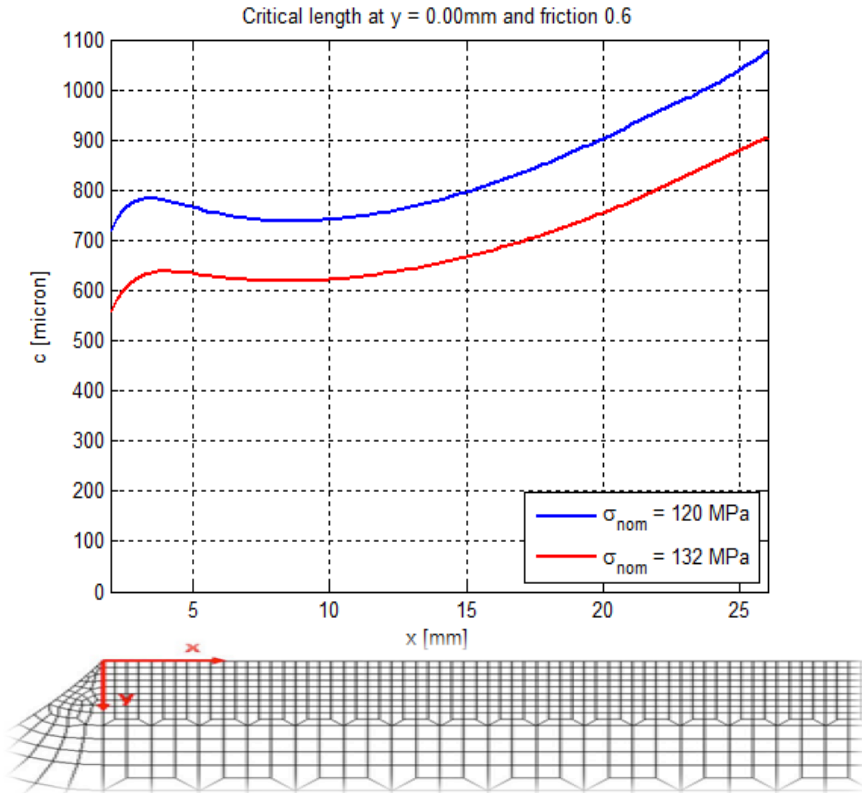
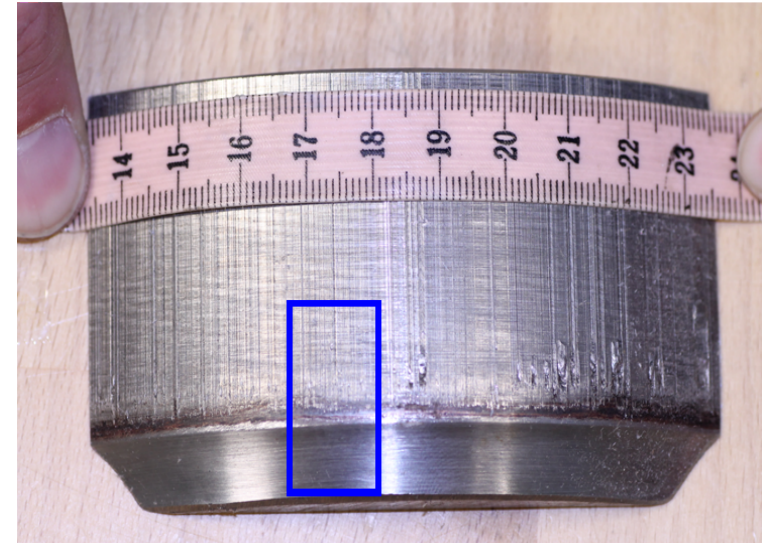
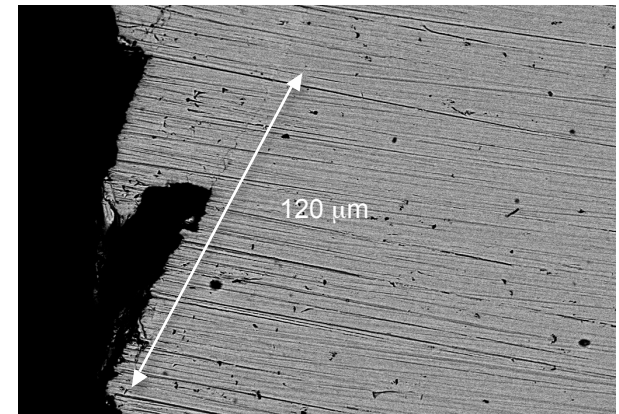
Run-out specimen  $\sigma_{nom} = 120$  MPa

Non propagating cracks on run-out specimen ( $\sigma = 120$  MPa)

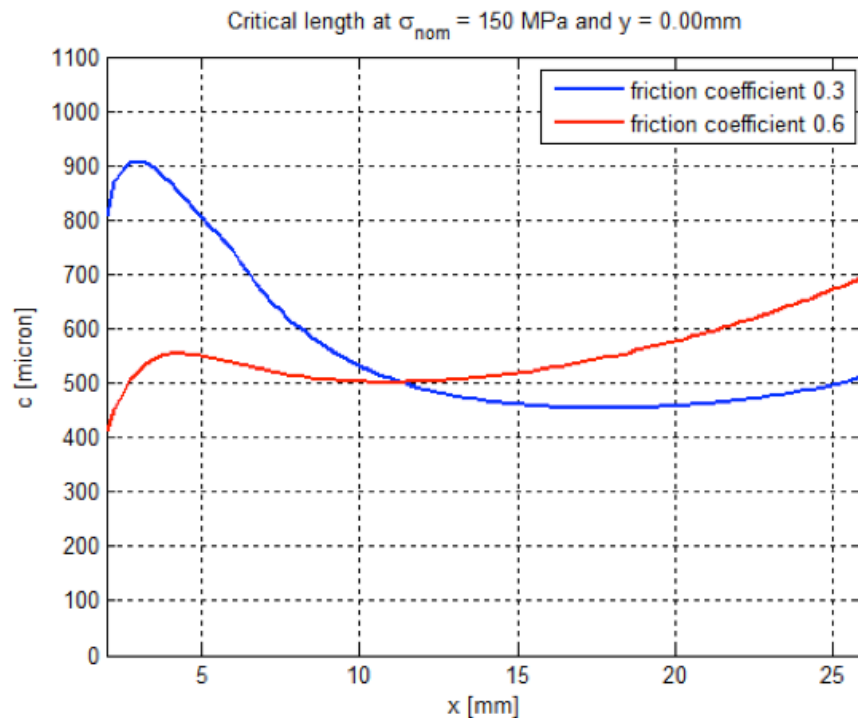
F4 ( $D/d = 1.08$ ) Minden test	$\sigma_{nom}$ (failure)	Critical crack size	Critical position along x
friction coefficient = 0.3	150 MPa	450 $\mu\text{m}$	12 - 24 mm
friction coefficient = 0.6	150 MPa	500 $\mu\text{m}$	6 - 14 mm

No experimental observation of failure location.

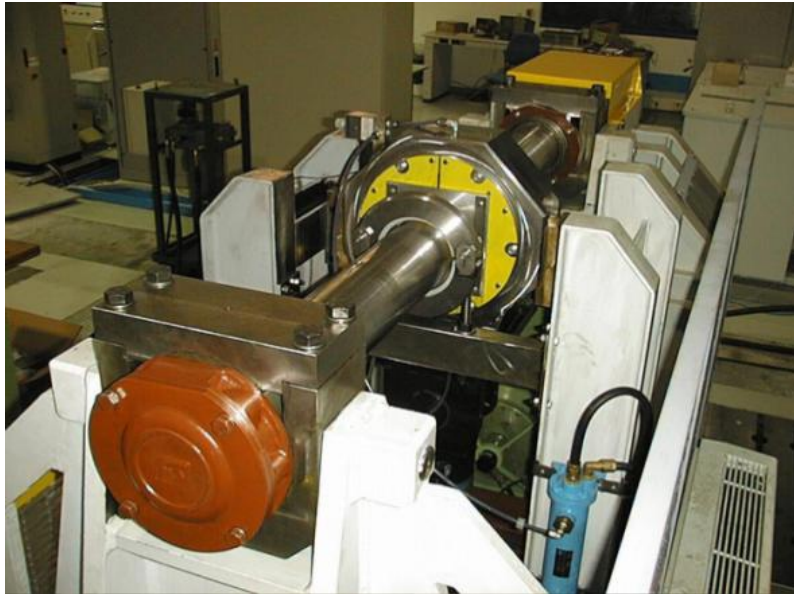
Full scale tests with artificial defects

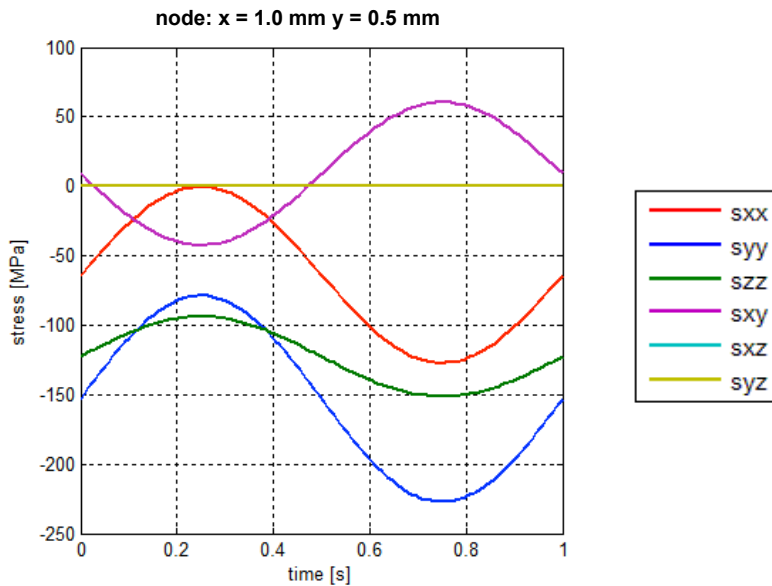
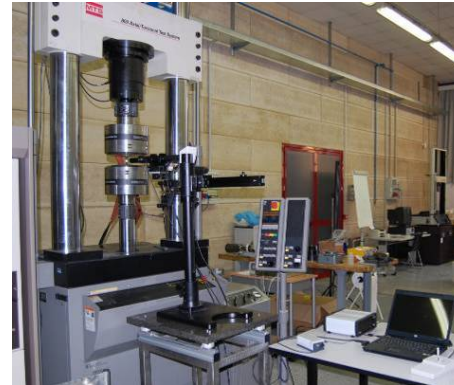
MTS 809 Axial-Torsional Test System

Fatigue tests on specimens with artificial defects with a loading path similar to the one experienced by the crack under the press fit
