Fatigue properties of railway axles: new results of full-scale specimens

Steven Cervello
Lucchini RS, Italy

TC24 Meeting – Advances in: “*Axle Durability Analysis and Maintenance*”

Politecnico di Milano 1-2 October 2014

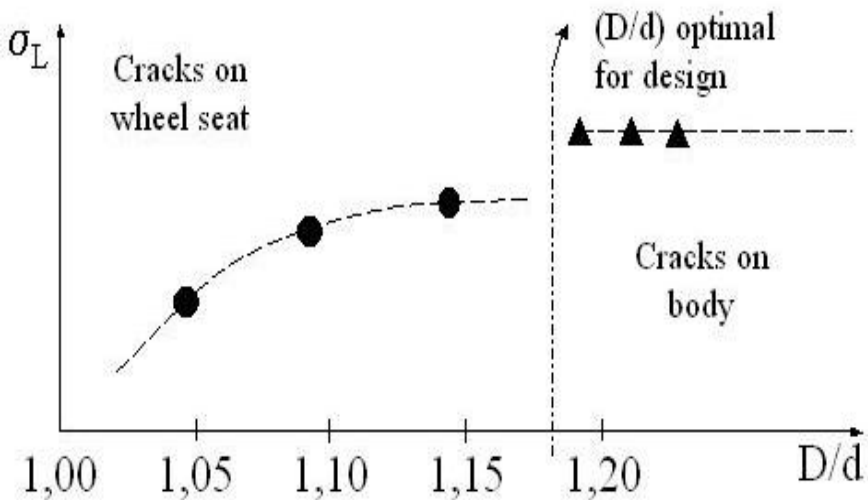
F3/F4 : press fitted seat fatigue limit (solid or bore axle)

It's the nominal stress at the seat edge

- The nominal stress is evaluated by interpolation of two strain gauges on the body

- Cracks appear as a consequence of the micro slip between seat and hub due to bending (Fretting phenomena)

- The fatigue limit depends on the diameter ratio (D/d), but also on the transition shape (particularly the transition slope near to the seat edge)

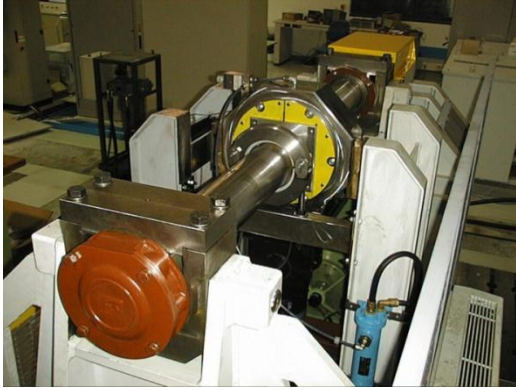
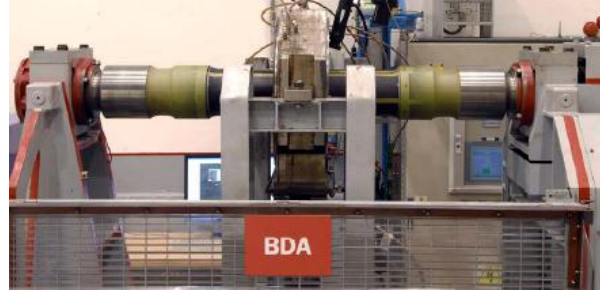
Vitry type test rig

- symmetric axle
- 3 point rotating bending
- test control through load F
- static strain/load calibration

Task 3.2 Material testing - Test rigs involved in the testing

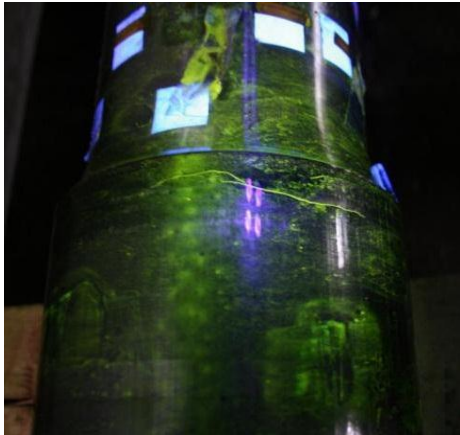
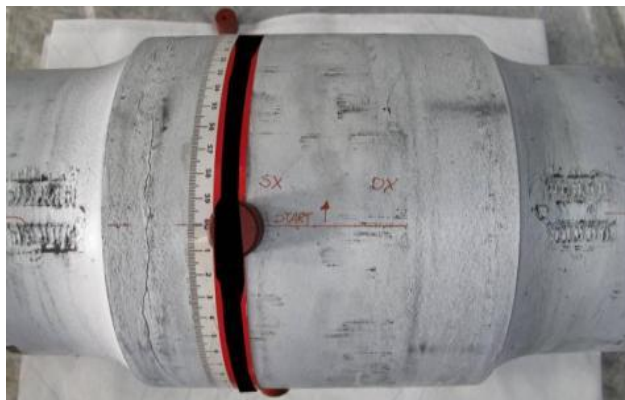
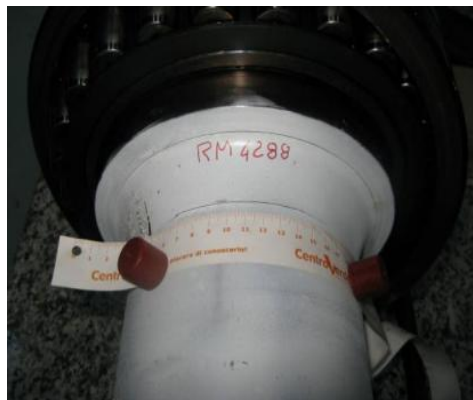
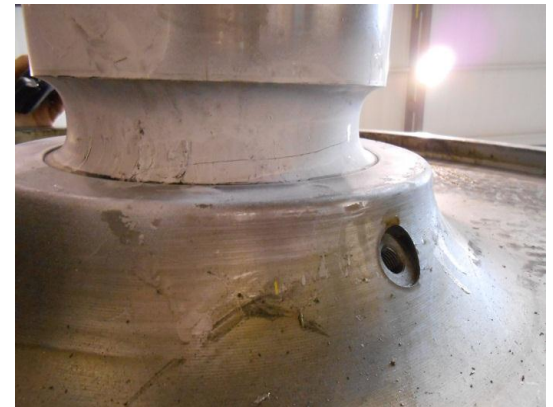
- **F1 (full scale) Standard surface – A4T**
 - Examples of cracks obtained during the tests

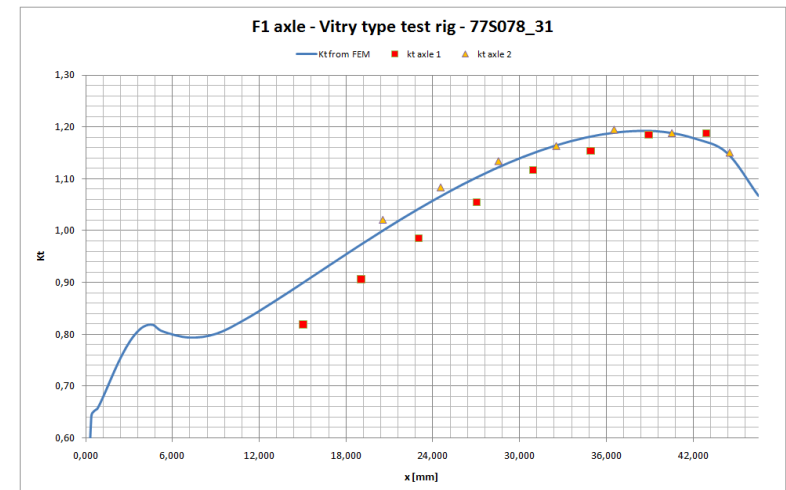
- **F1 (full scale) Standard surface – A4T**
 - Stress concentration in the transitions

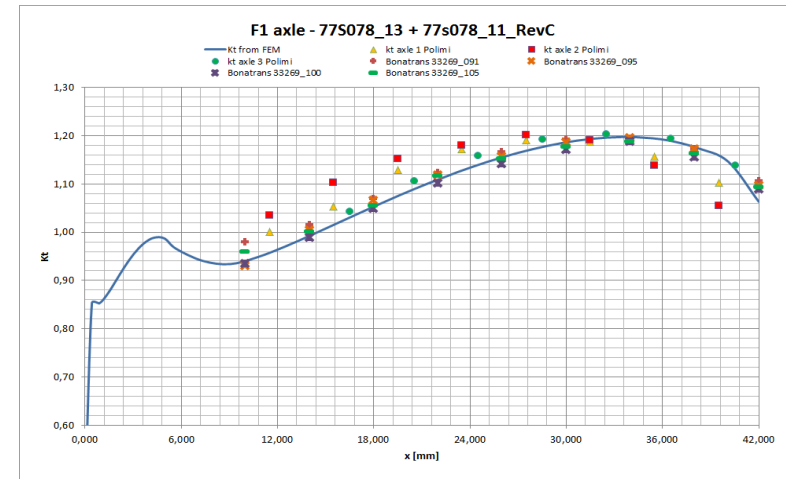
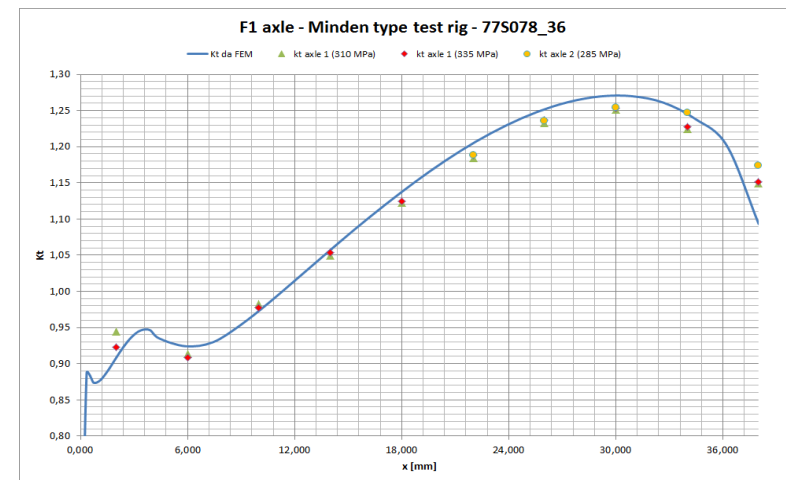
- **F1 (full scale) Standard surface – A4T**
 - Stress concentration in the transitions

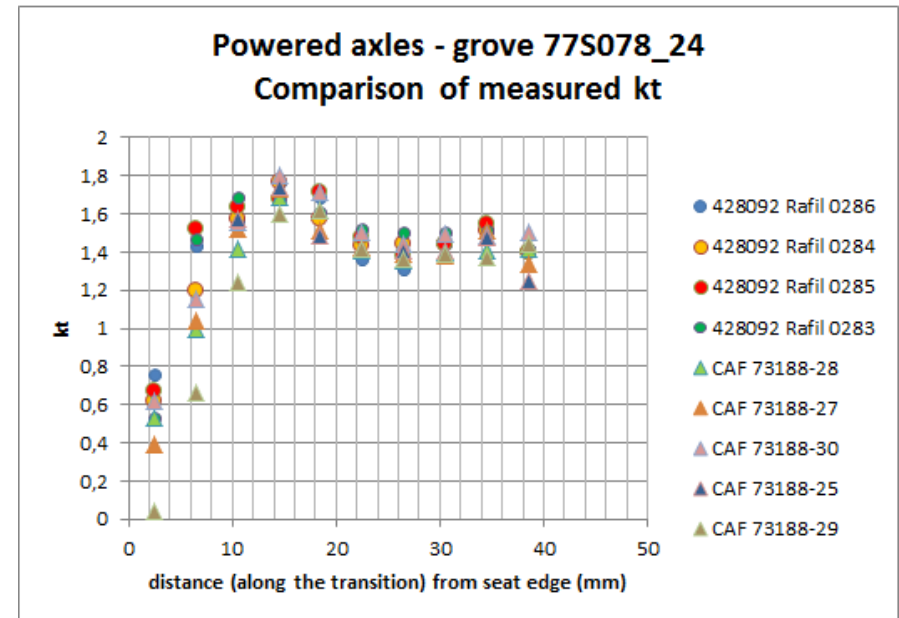
- **F1 (full scale) Standard surface – A4T**
 - Stress concentration in the grooves

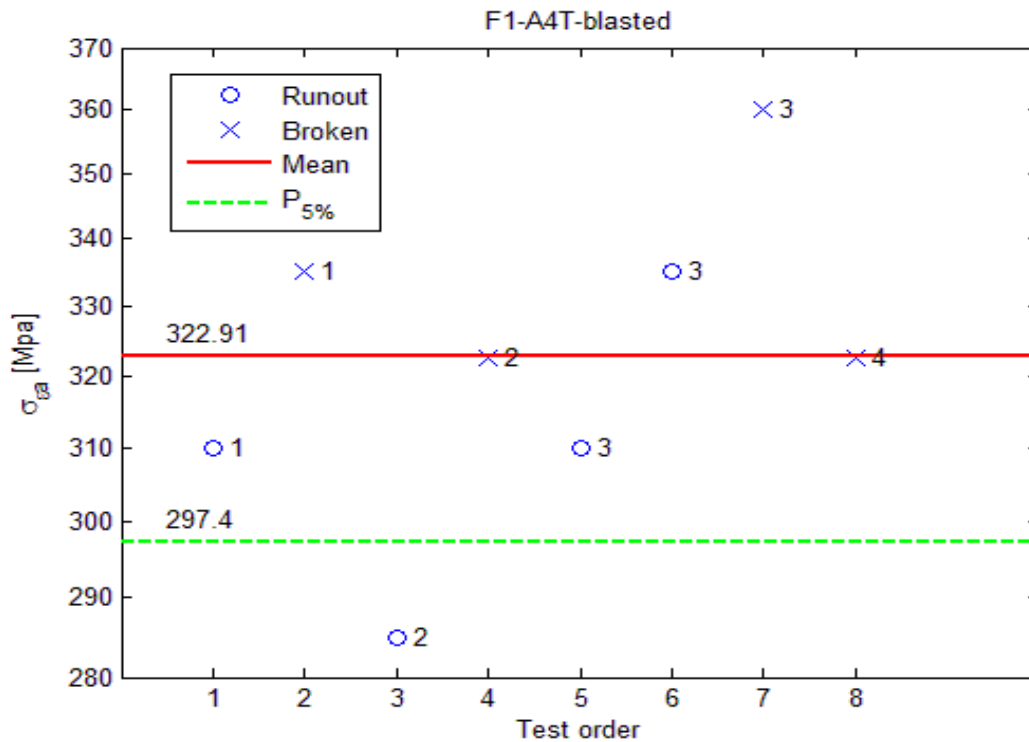
Stair case fatigue test results of F1 A4T axles blasted at a roughness of 6-7 Ra

50% fatigue limit	322,9
Standard deviation	13
5% probability of failure	297,4

Increase of the fatigue limit is probably due to the compressive stresses generated by the blasting process

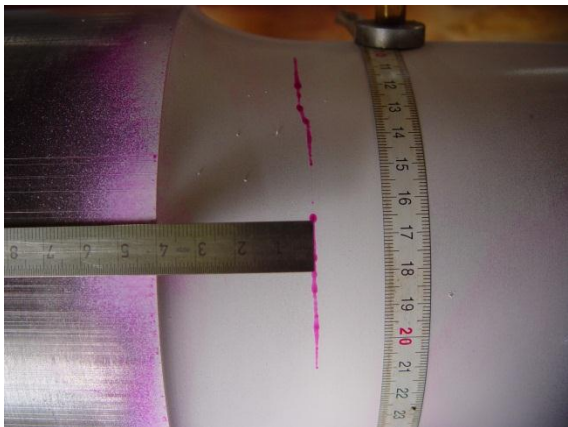
- **F1 (full scale) Standard surface – A1N**
 - For A1N cracks appear all on the base of the transition (never on the seat)

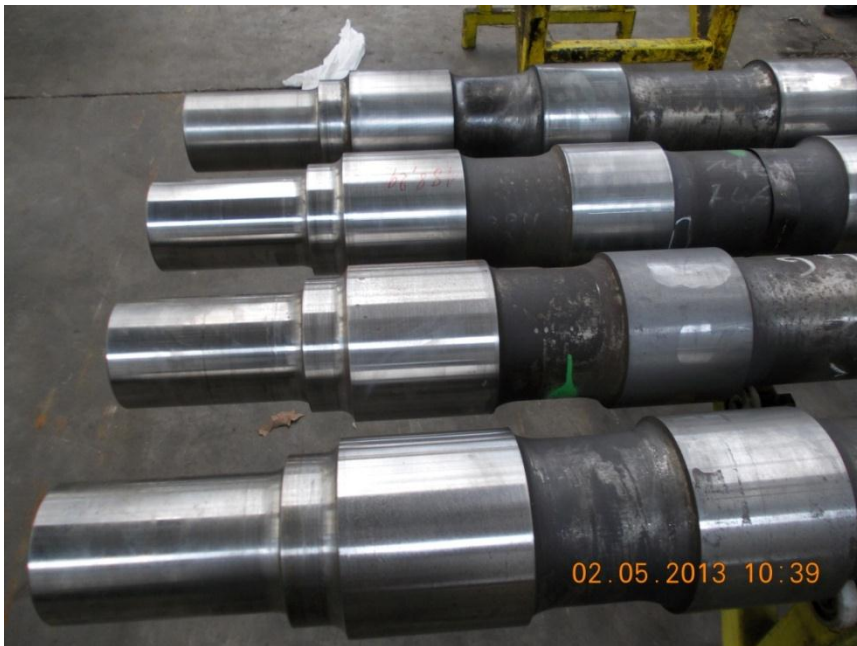
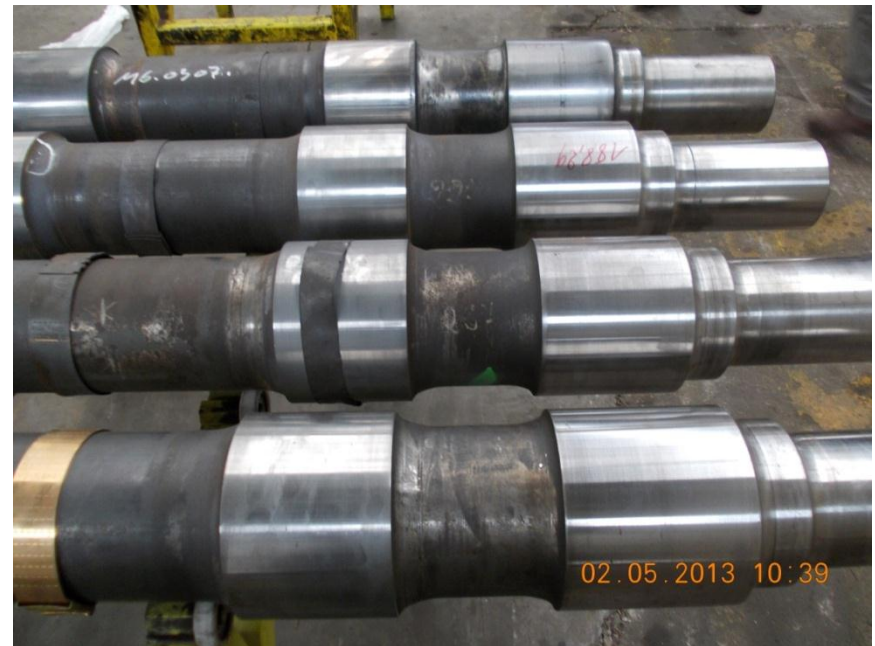
- **F1 (full scale) Effect of corrosion**

Unpainted axles are normally used by SNCB (Belgium Railways);

Axles show a uniform corrosion

Axles are in A1N steel grade and have been in service for 10 year

$D=188$, $d=160$, $D/d=1,175$

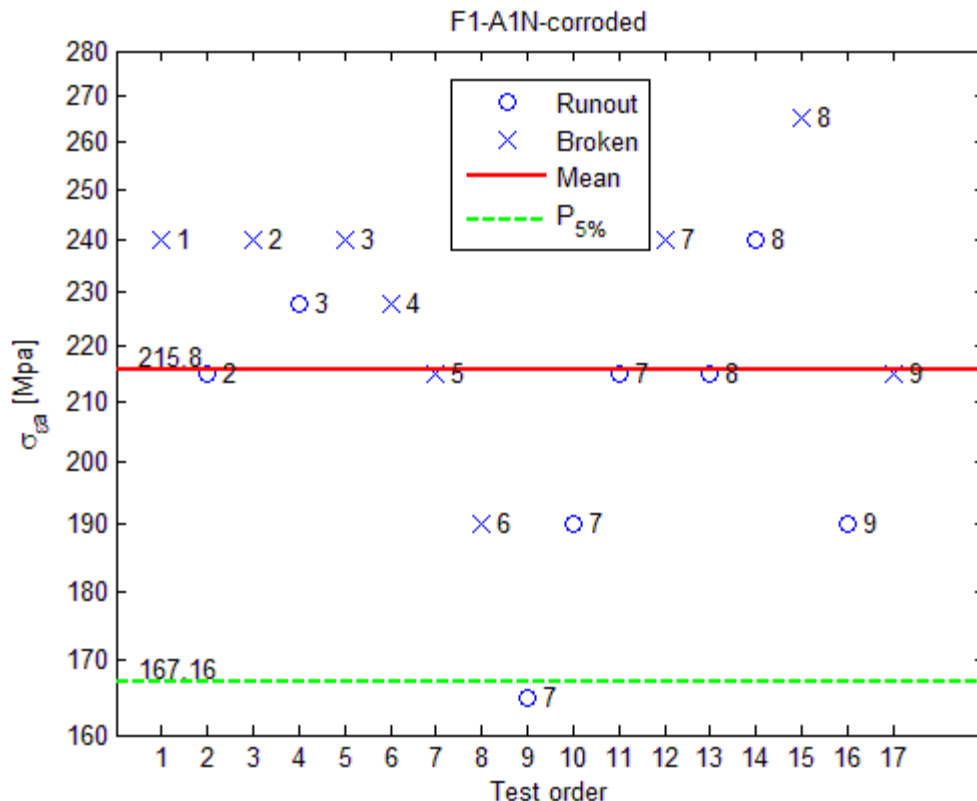
- Unpainted axles are normally used by SNCB (Belgium Railways);
- Axles show a uniform corrosion
- Axles are in A1N steel grade and have been in service for 10 year

50% fatigue limit	215,8
Standard deviation	24,8
5% probability of failure	167,2

- The results of the fatigue tests performed on unpainted corroded axles from service show a reduction of about 17% from the standard new axles.
- In this case the additional safety factor to be used in the design would be : $258/216 = 1,19$ instead of 1,3 as reported in the European Standards, but it must be considered that this is a specific condition and may not be valid in general.
- For local corrosion the damaging effect will be more critical than for uniform distributed corrosion.
- The coating of painted axles shall always be repaired whenever coating detachments are found during maintenance visual inspections (in line with EVIC guidelines).

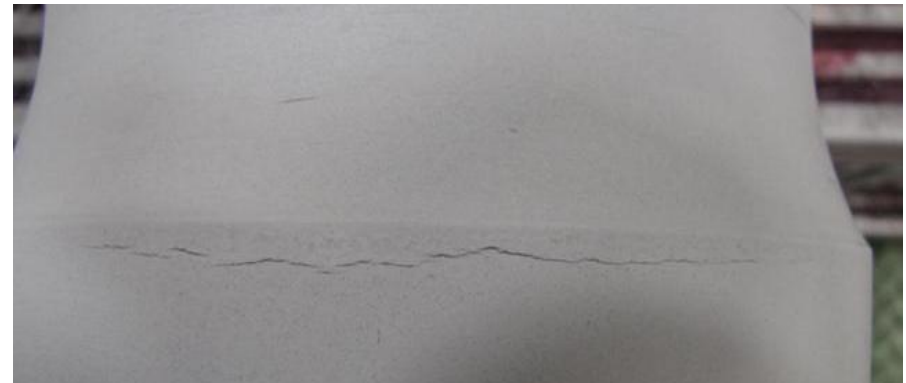
- 1,12 is the ratio required for the F4 qualification of axles; for A4T, F4 = 132 MPa
- The transition geometry is representative of a standard axle with a reprofiled seat.
- Test performed both on the Minden and Vitry type test rig

50% fatigue limit	123,8
Standard deviation	4,5
5% probability of failure	114,9

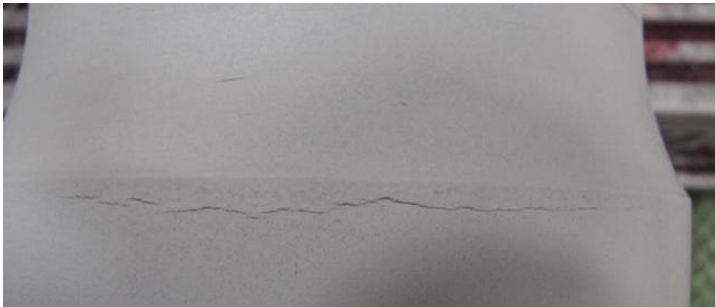
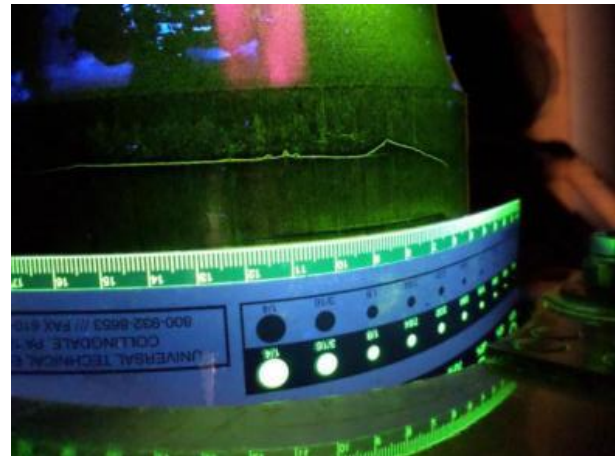
Example of crack detected during the tests

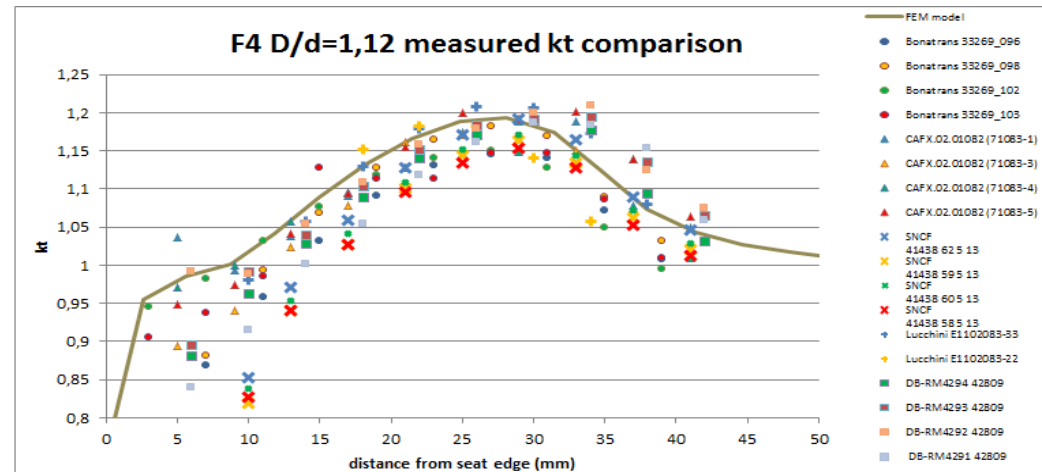
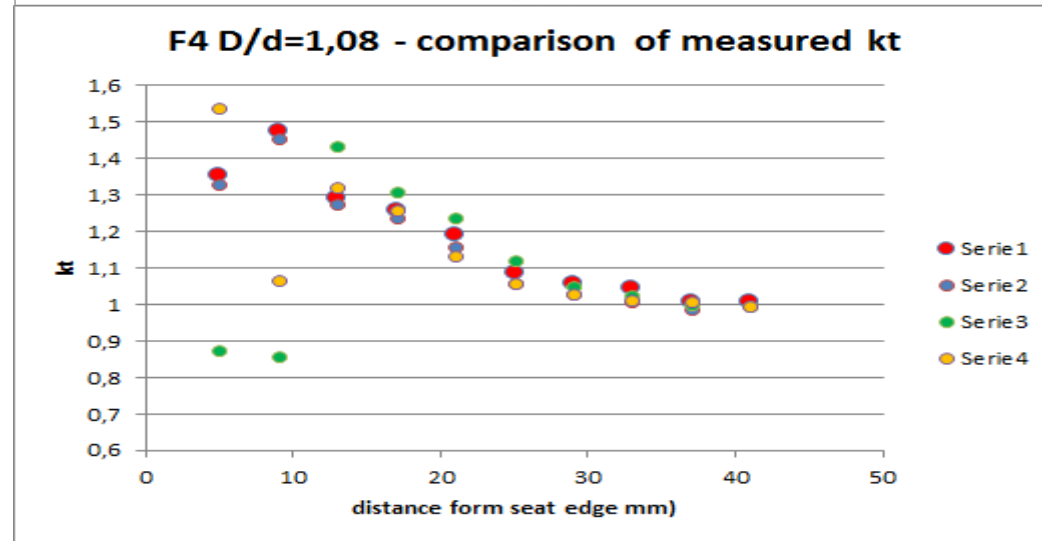
- F4 (full scale) comparison between $D/d = 1,12$ and $1,08$
 - Stress concentration factors along the transitions
